## **Hydrogeology Study**

### **Future Solid Waste Disposal Needs Environmental Assessment**

**Town of St. Marys**

**June 2016  
300032339.0000**

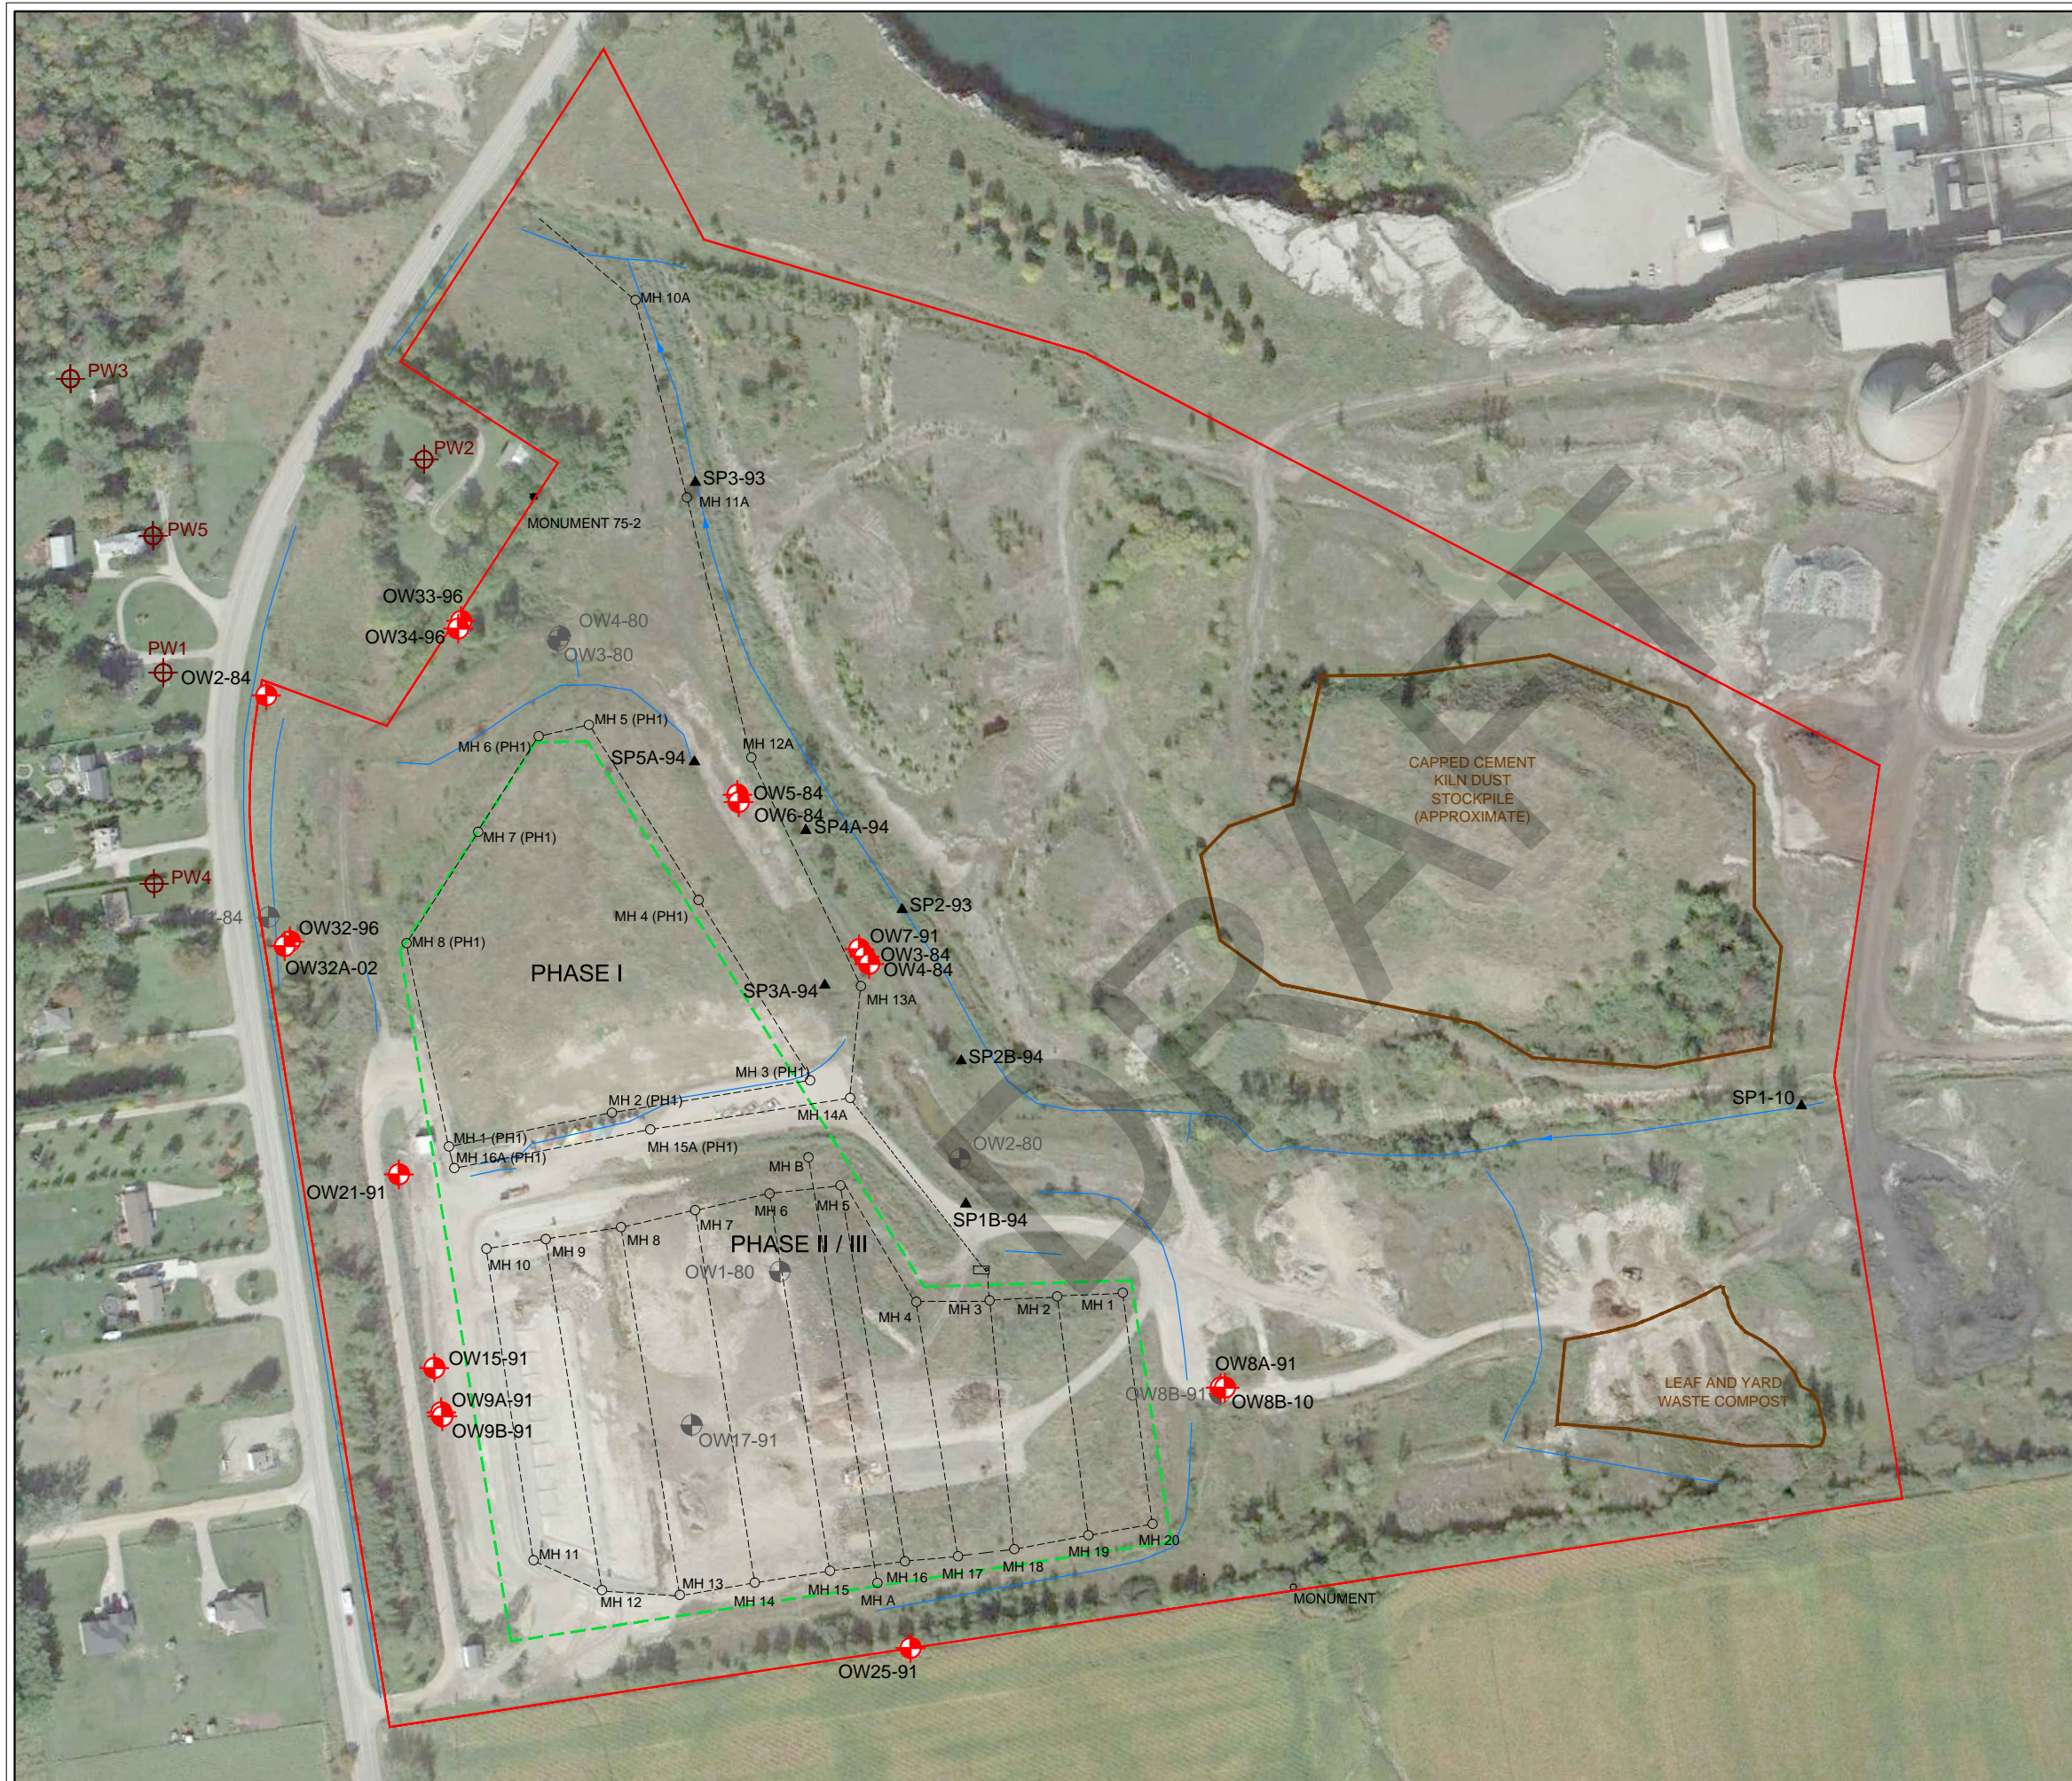
Figure Title  
**MONITORING LOCATIONS**

AIR PHOTO SOURCE:  
GOOGLE EARTH PRO 2013 SATELLITE IMAGE

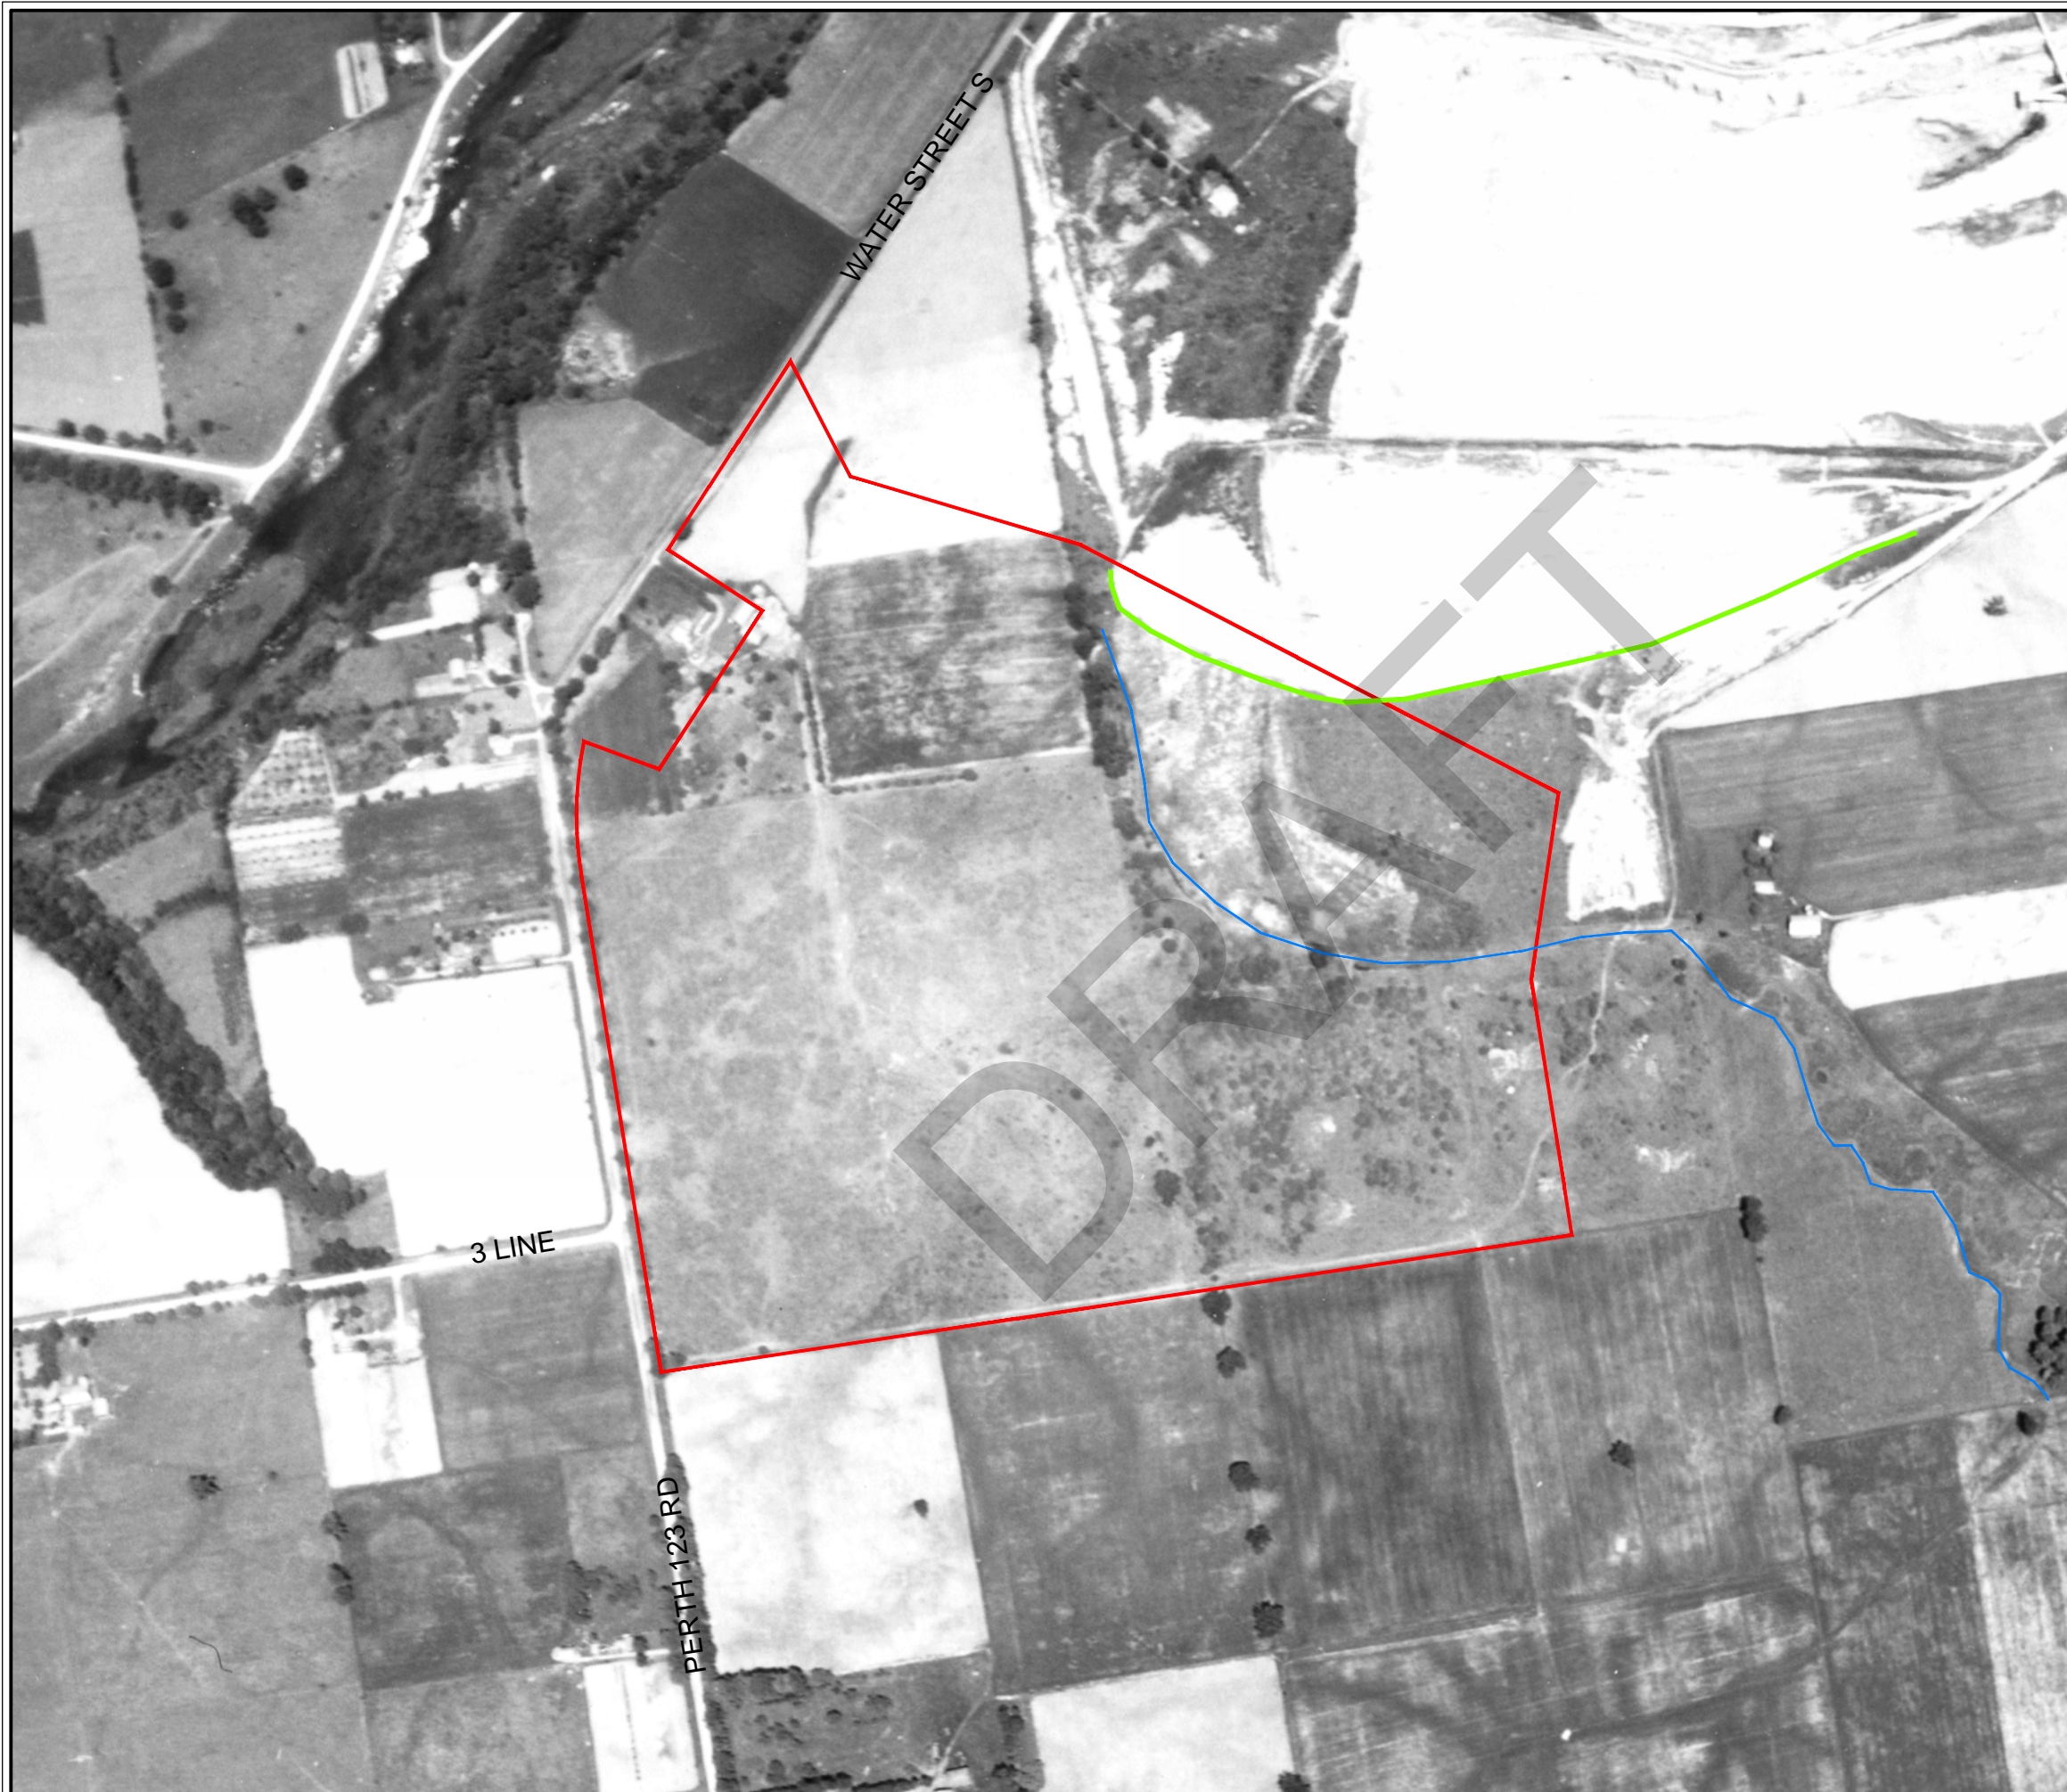
Drawn SK	Checked CM	Date March 2016	Figure No. <b>A-1</b>
Scale 1:5,000	Project No. 300032339

- CURRENT PROPERTY BOUNDARY
- SOUTHERN EXTENT OF QUARRYING
- WATERCOURSE

Figure Title  
**1955 AIR PHOTO**

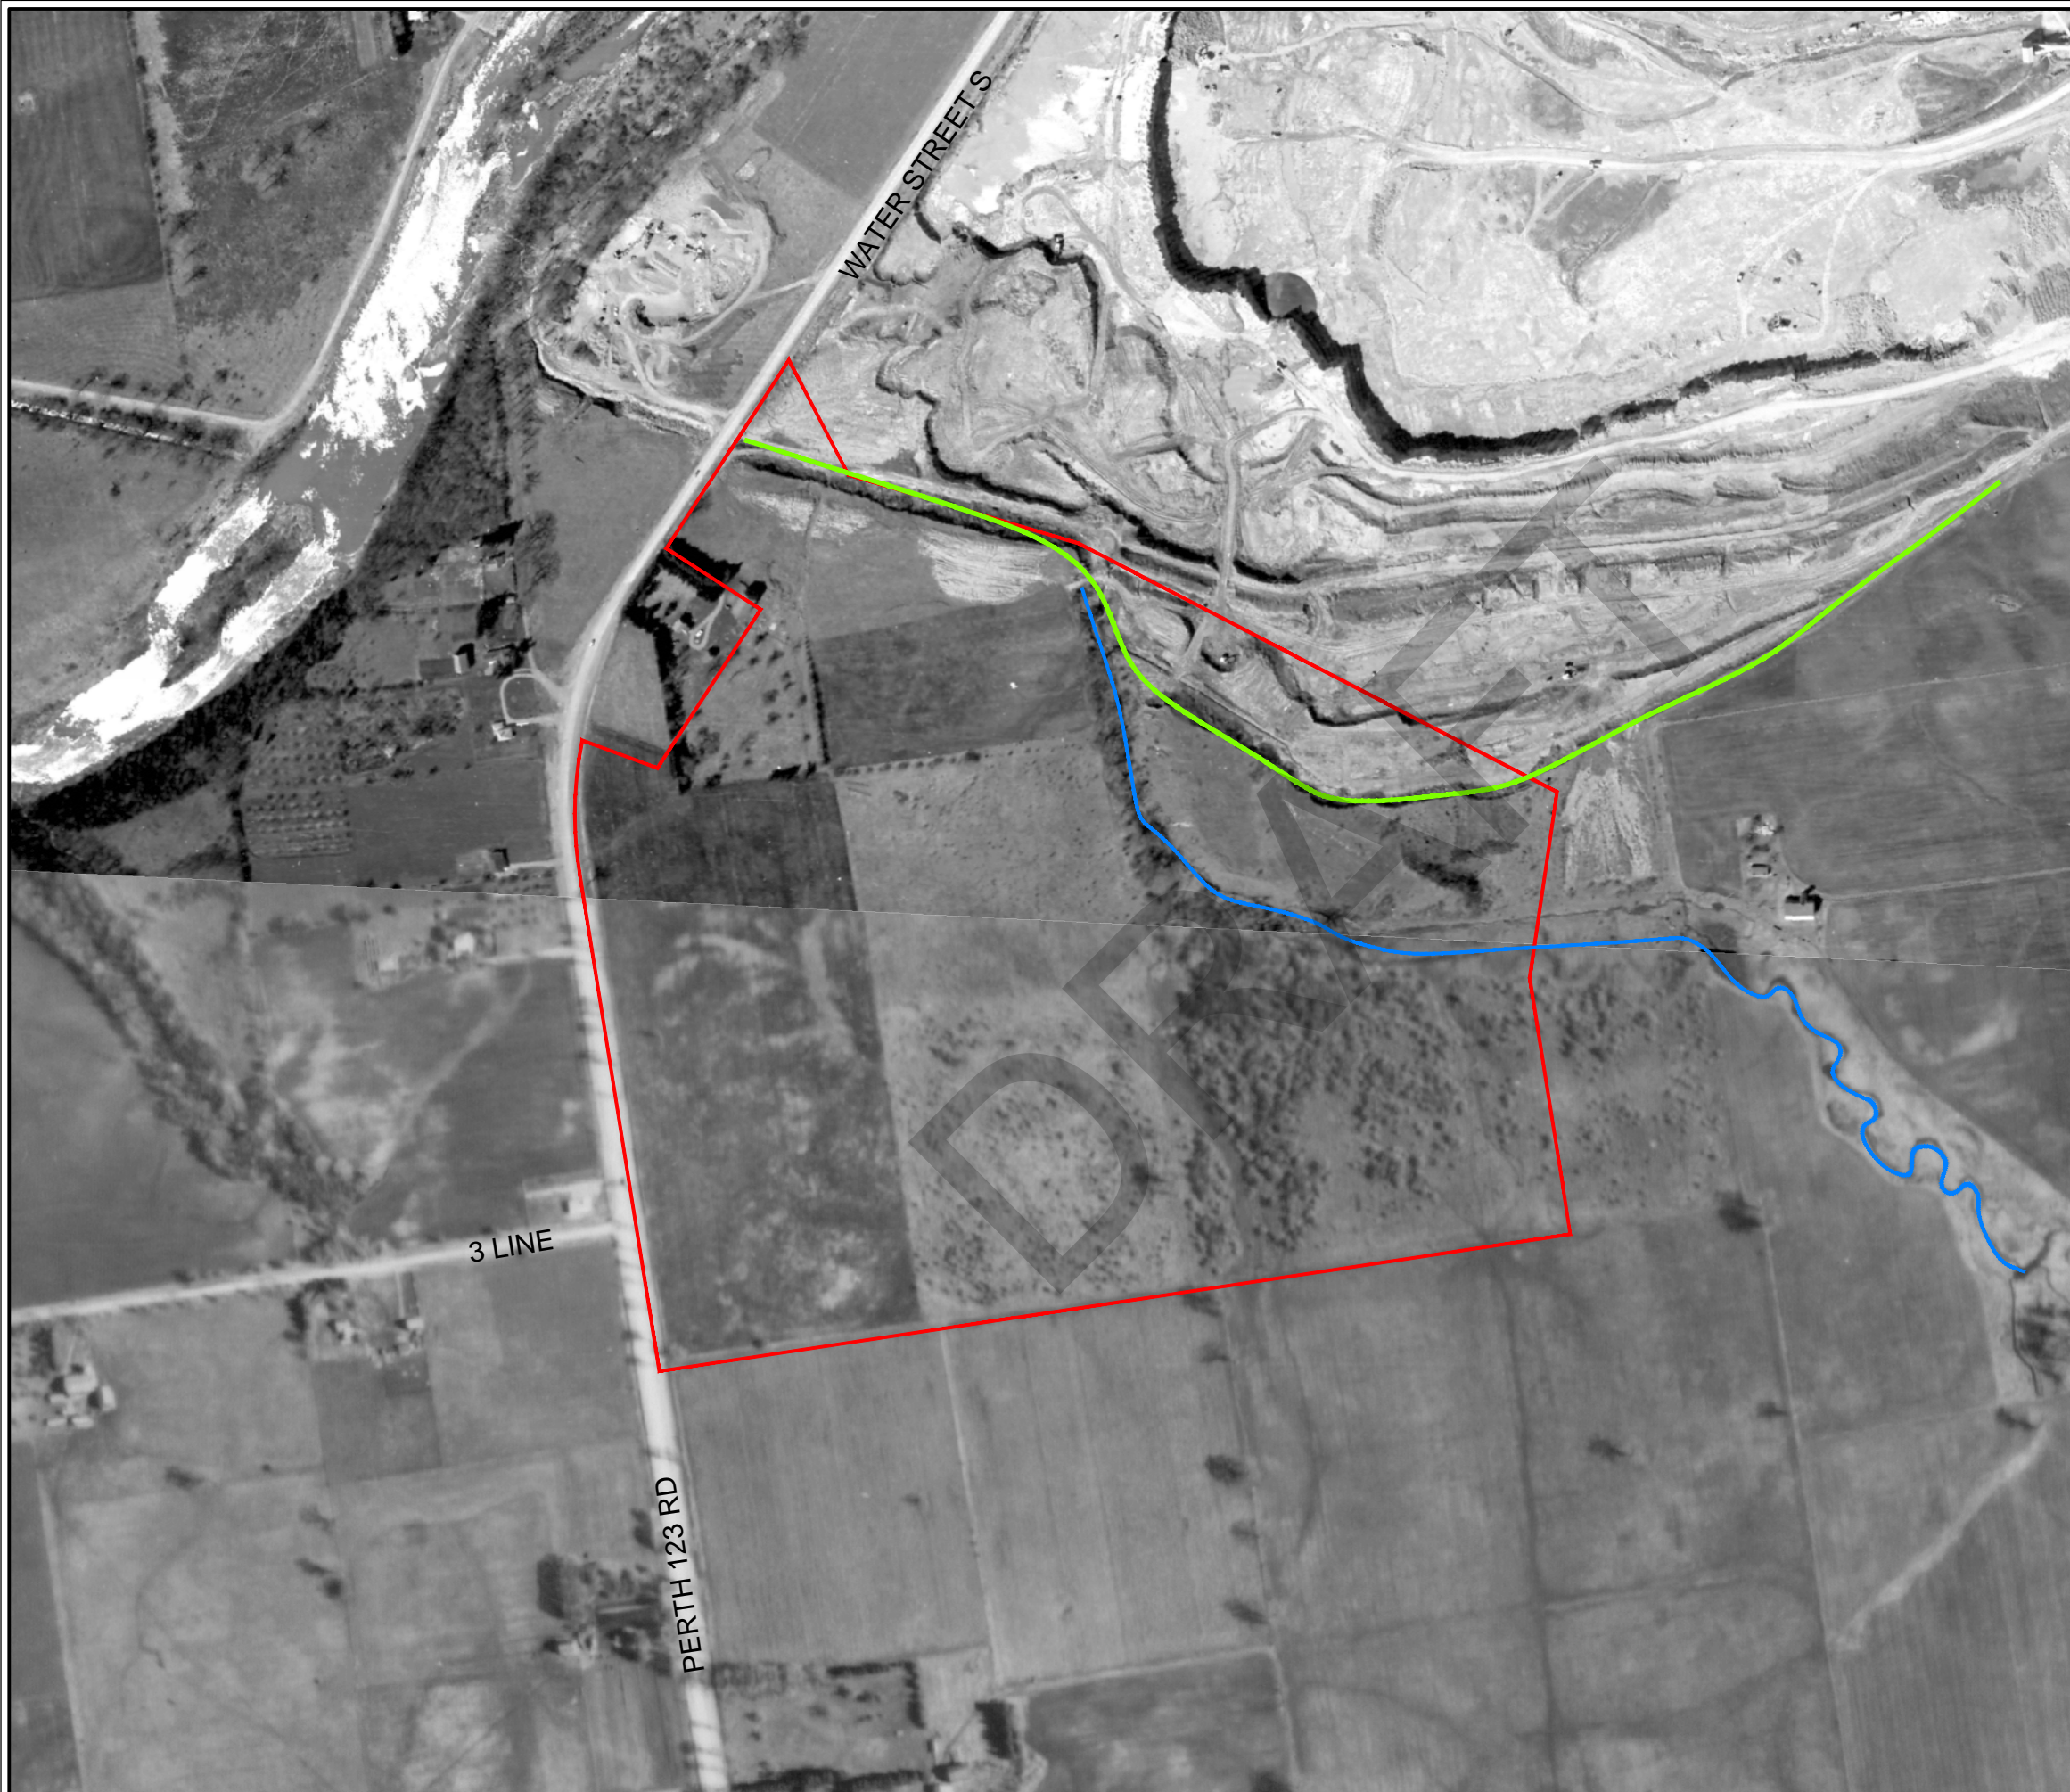
Drawn	Checked	Date	<b>Figure No.</b>  <b>A-2</b>
SK	CM	March 2016	
Scale		Project No.	
1:5,000		300032339

- CURRENT PROPERTY BOUNDARY
- SOUTHERN EXTENT OF QUARRYING
- WATERCOURSE

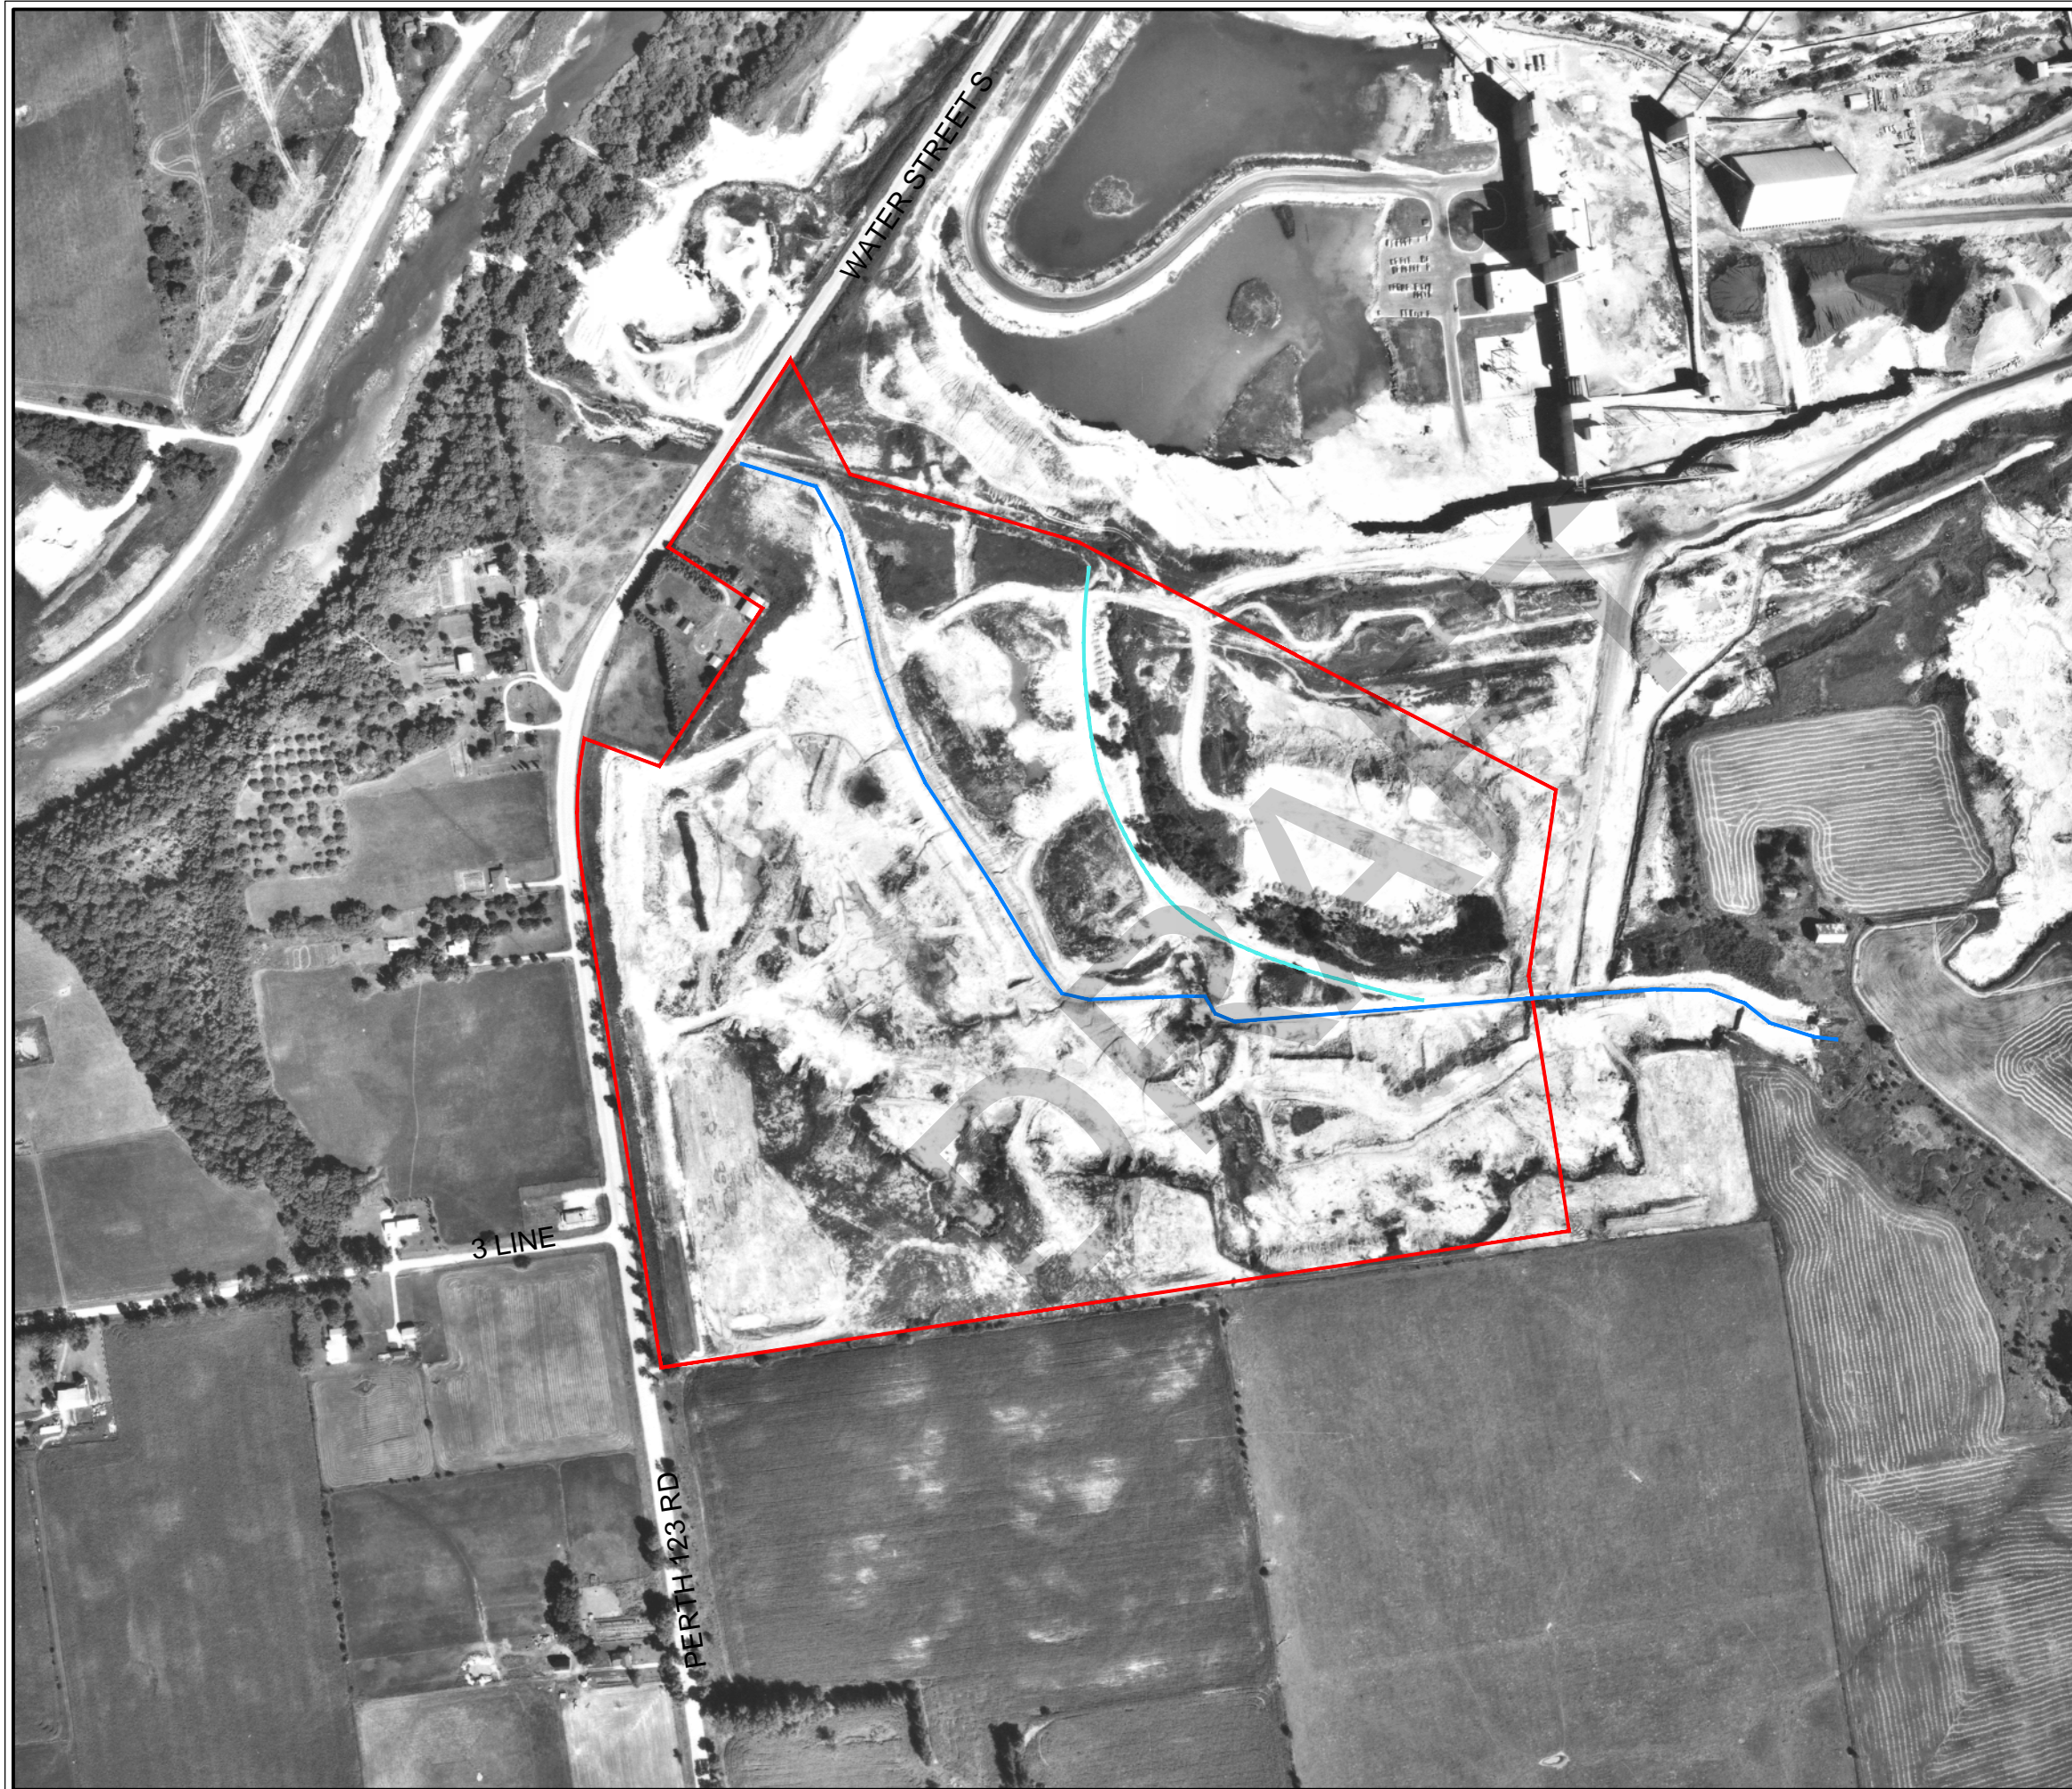
Drawn SK	Checked CM	Date March 2016	Figure No. <b>A-3</b>
Scale 1:5,000		Project No. 300032339

- CURRENT PROPERTY BOUNDARY
- FORMER WATERCOURSE
- NEW WATERCOURSE

**1978 AIR PHOTO**

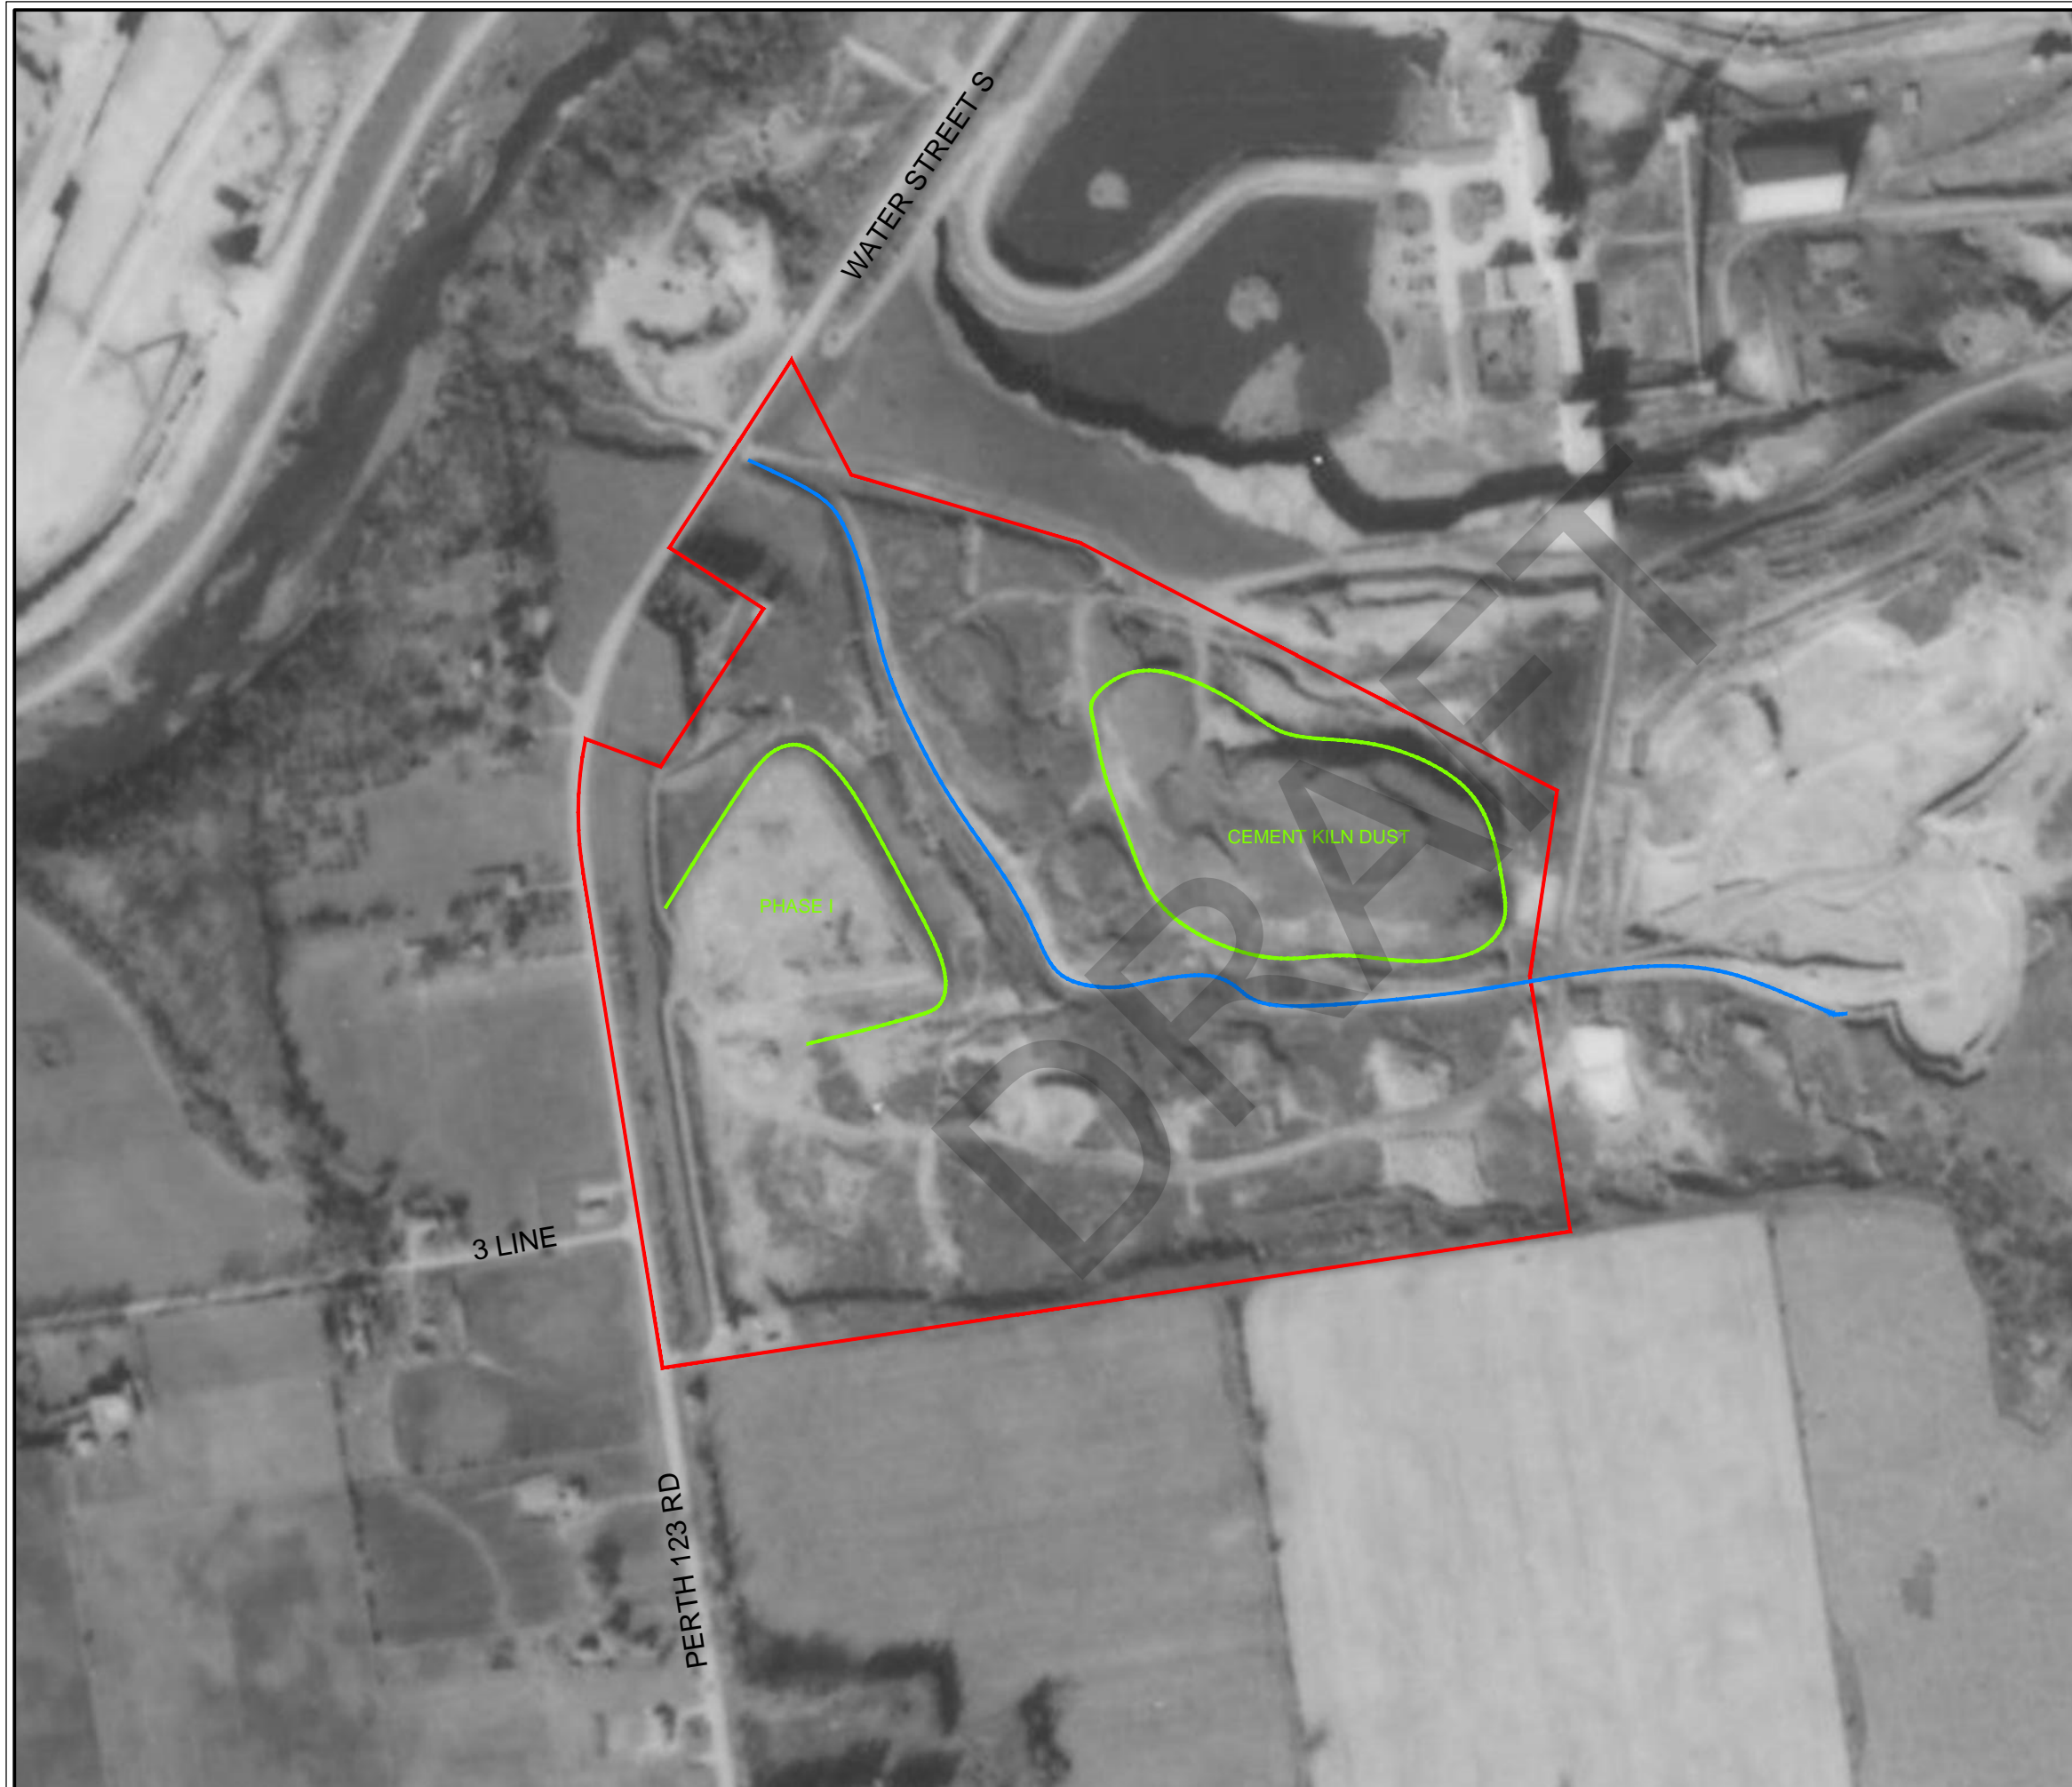
Drawn SK	Checked CM	Date March 2016	Figure No. <b>A-5</b>
Scale 1:5,000	Project No. 300032339

- CURRENT PROPERTY BOUNDARY
- WATERCOURSE
- FILLING

Figure Title  
**1989 AIR PHOTO**

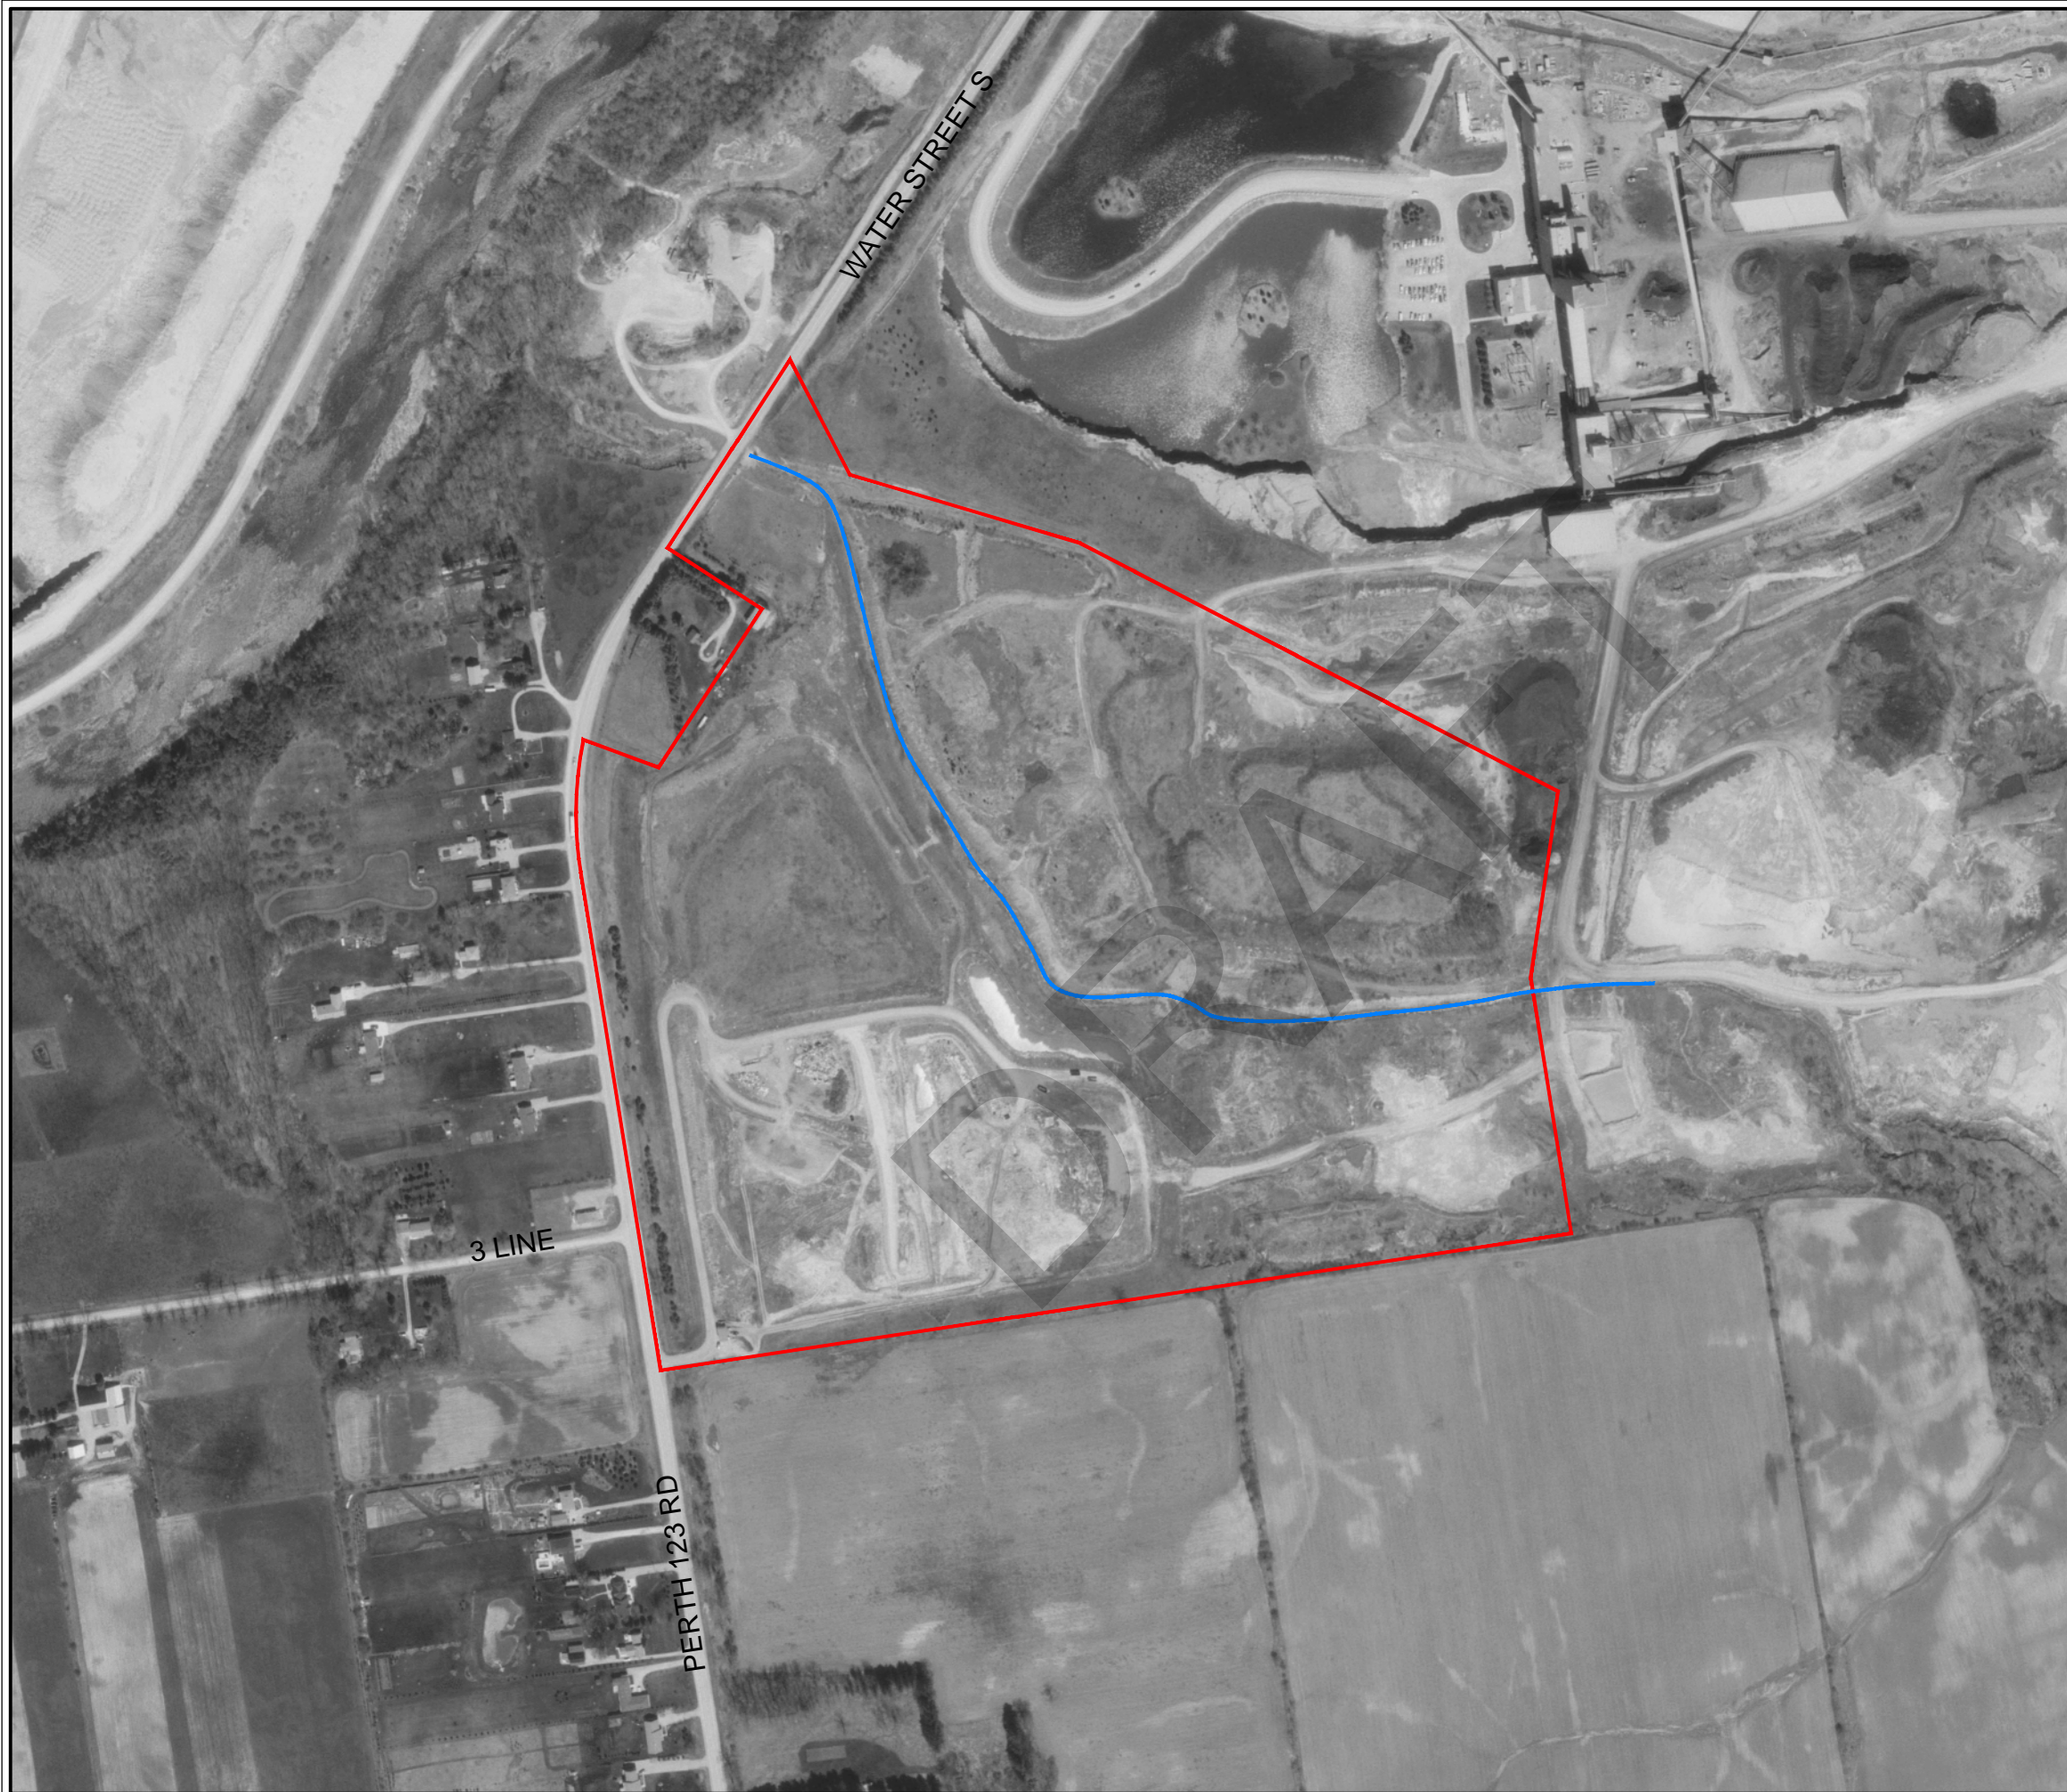
Drawn SK	Checked CM	Date March 2016	Figure No. <b>A-6</b>
Scale 1:5,000	Project No. 300032339

- CURRENT PROPERTY BOUNDARY
- WATERCOURSE

Figure Title  
**2000 AIR PHOTO**
