## **Hydrogeology Study**

### **Future Solid Waste Disposal Needs Environmental Assessment**

**Town of St. Marys**

**June 2016  
300032339.0000**

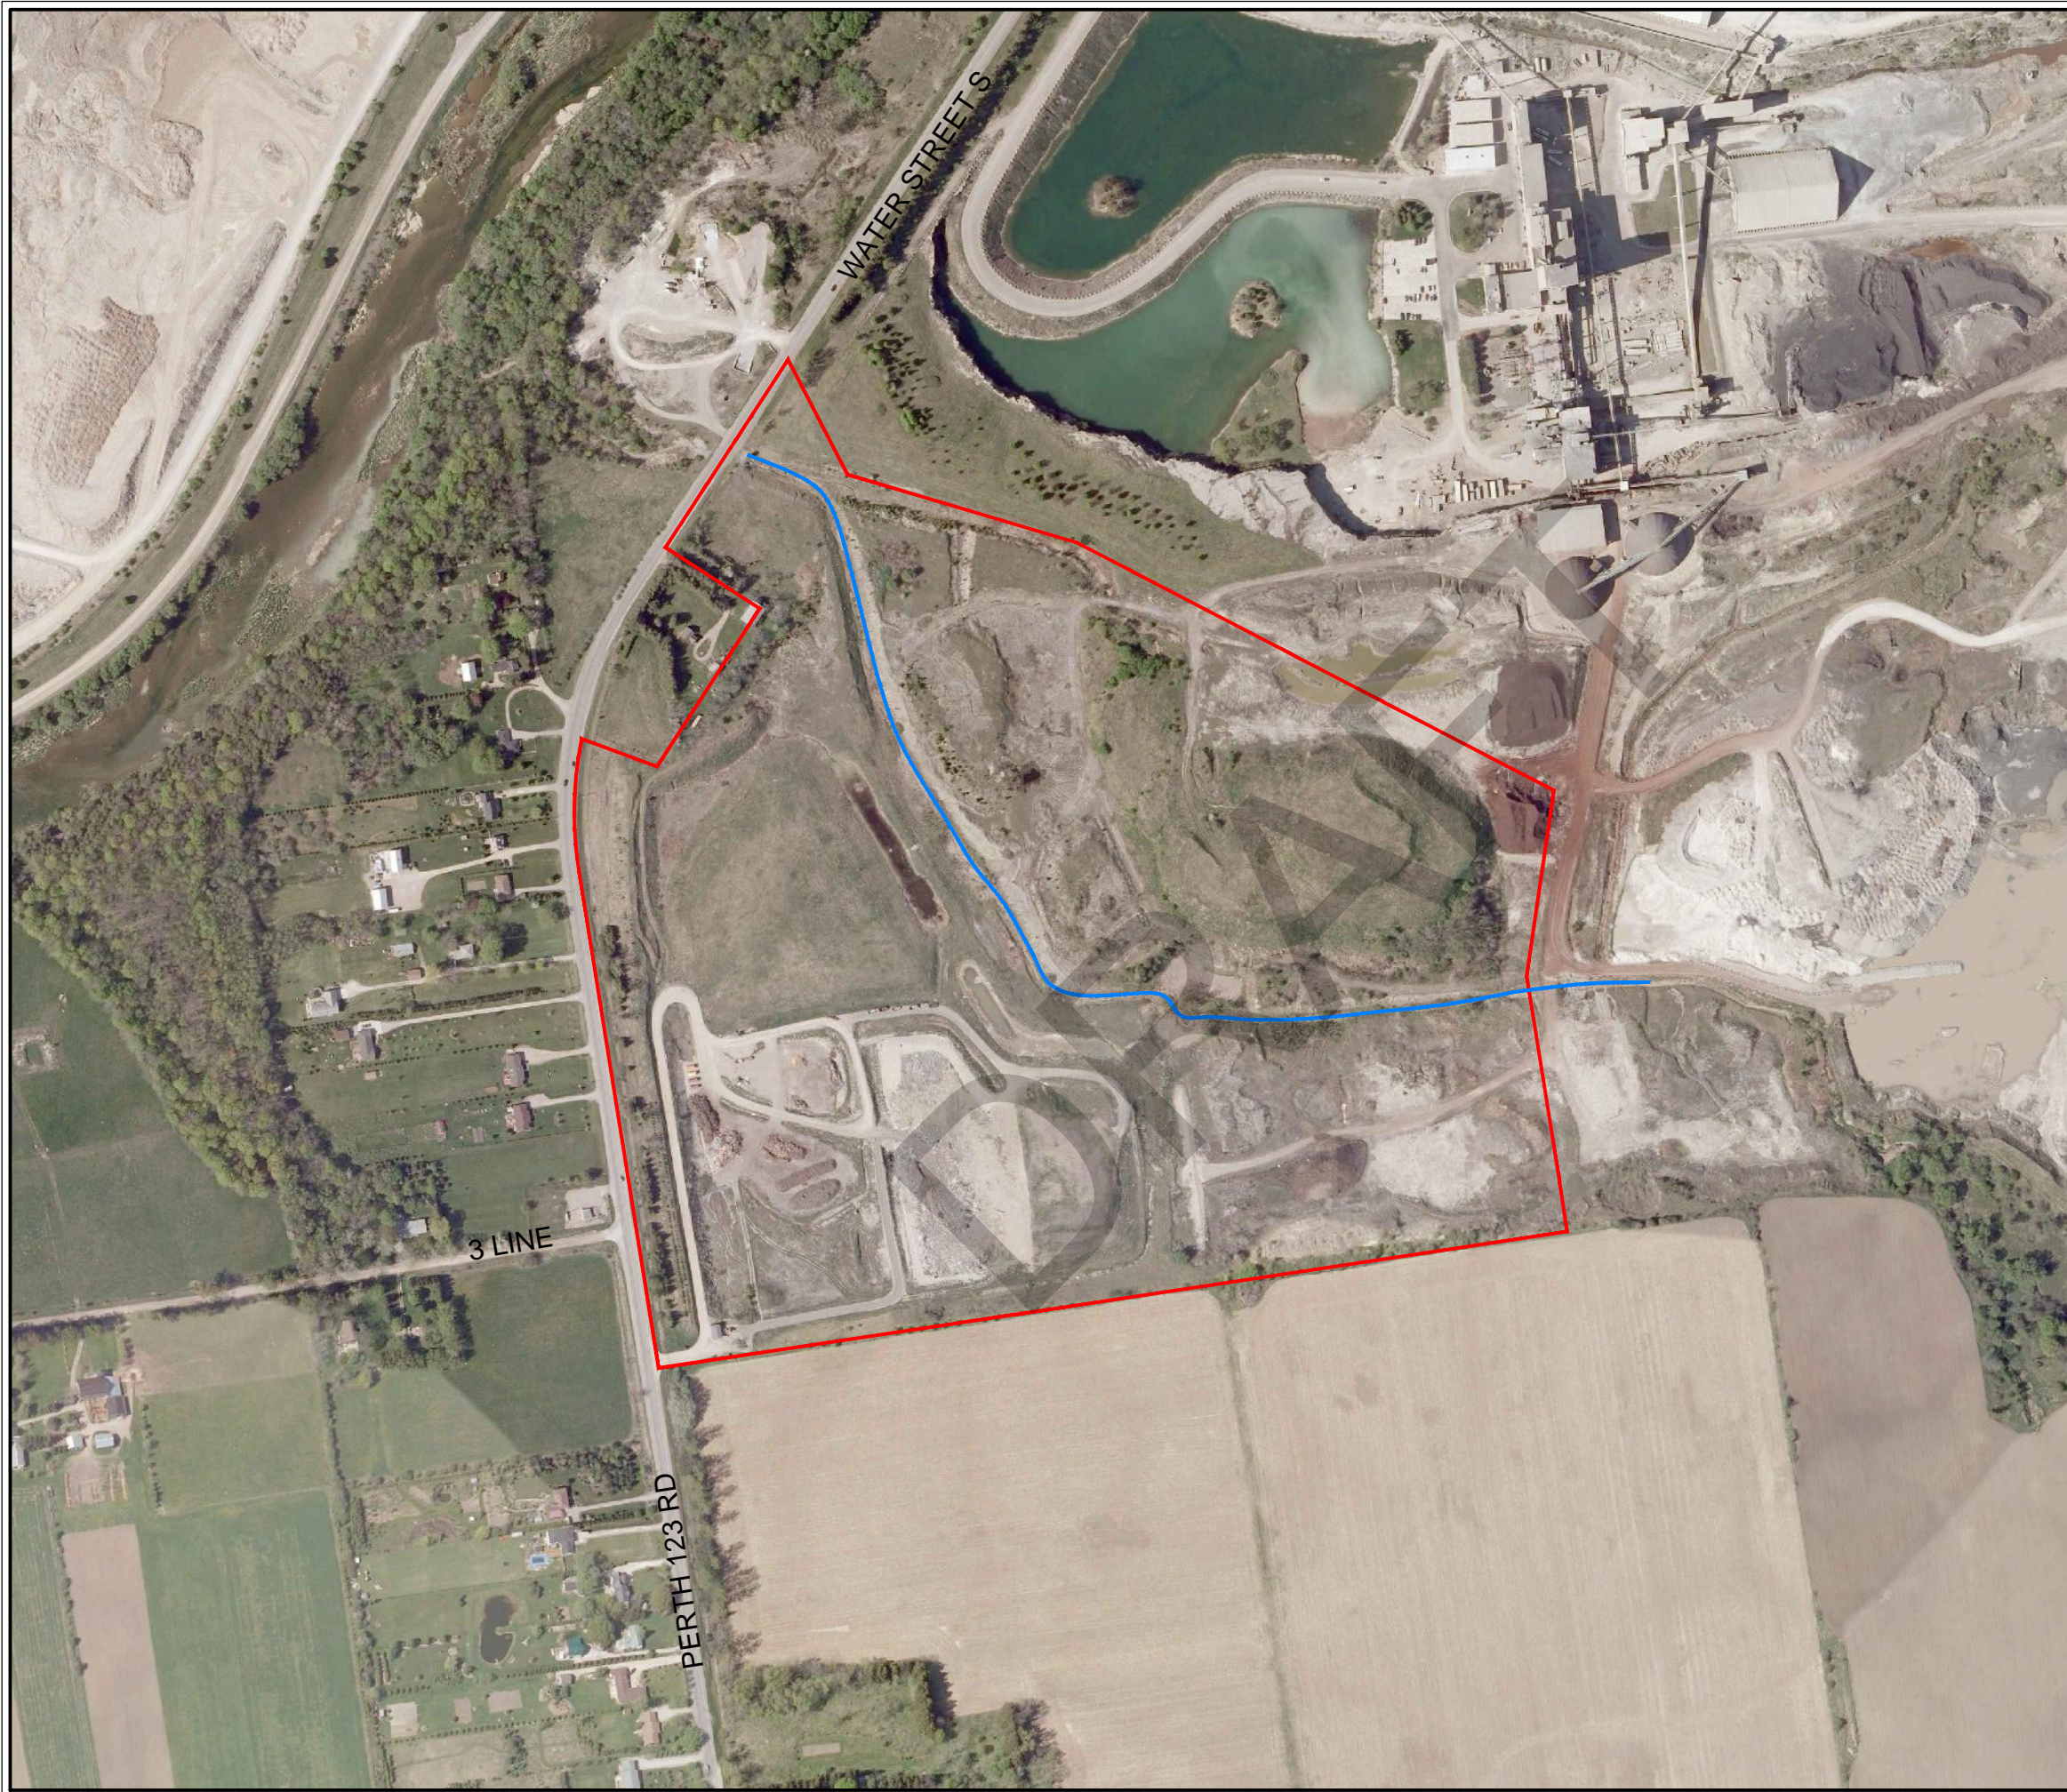
Drawn SK	Checked CM	Date March 2016	<b>A-7</b>
Scale 1:5,000	Project No. 300032339

- CURRENT PROPERTY BOUNDARY
- WATERCOURSE

**2006 AIR PHOTO**
