Hydrogeology Study

**Future Solid Waste Disposal Needs
Environmental Assessment**

Town of St. Marys

**December 2020
300032339.0000**

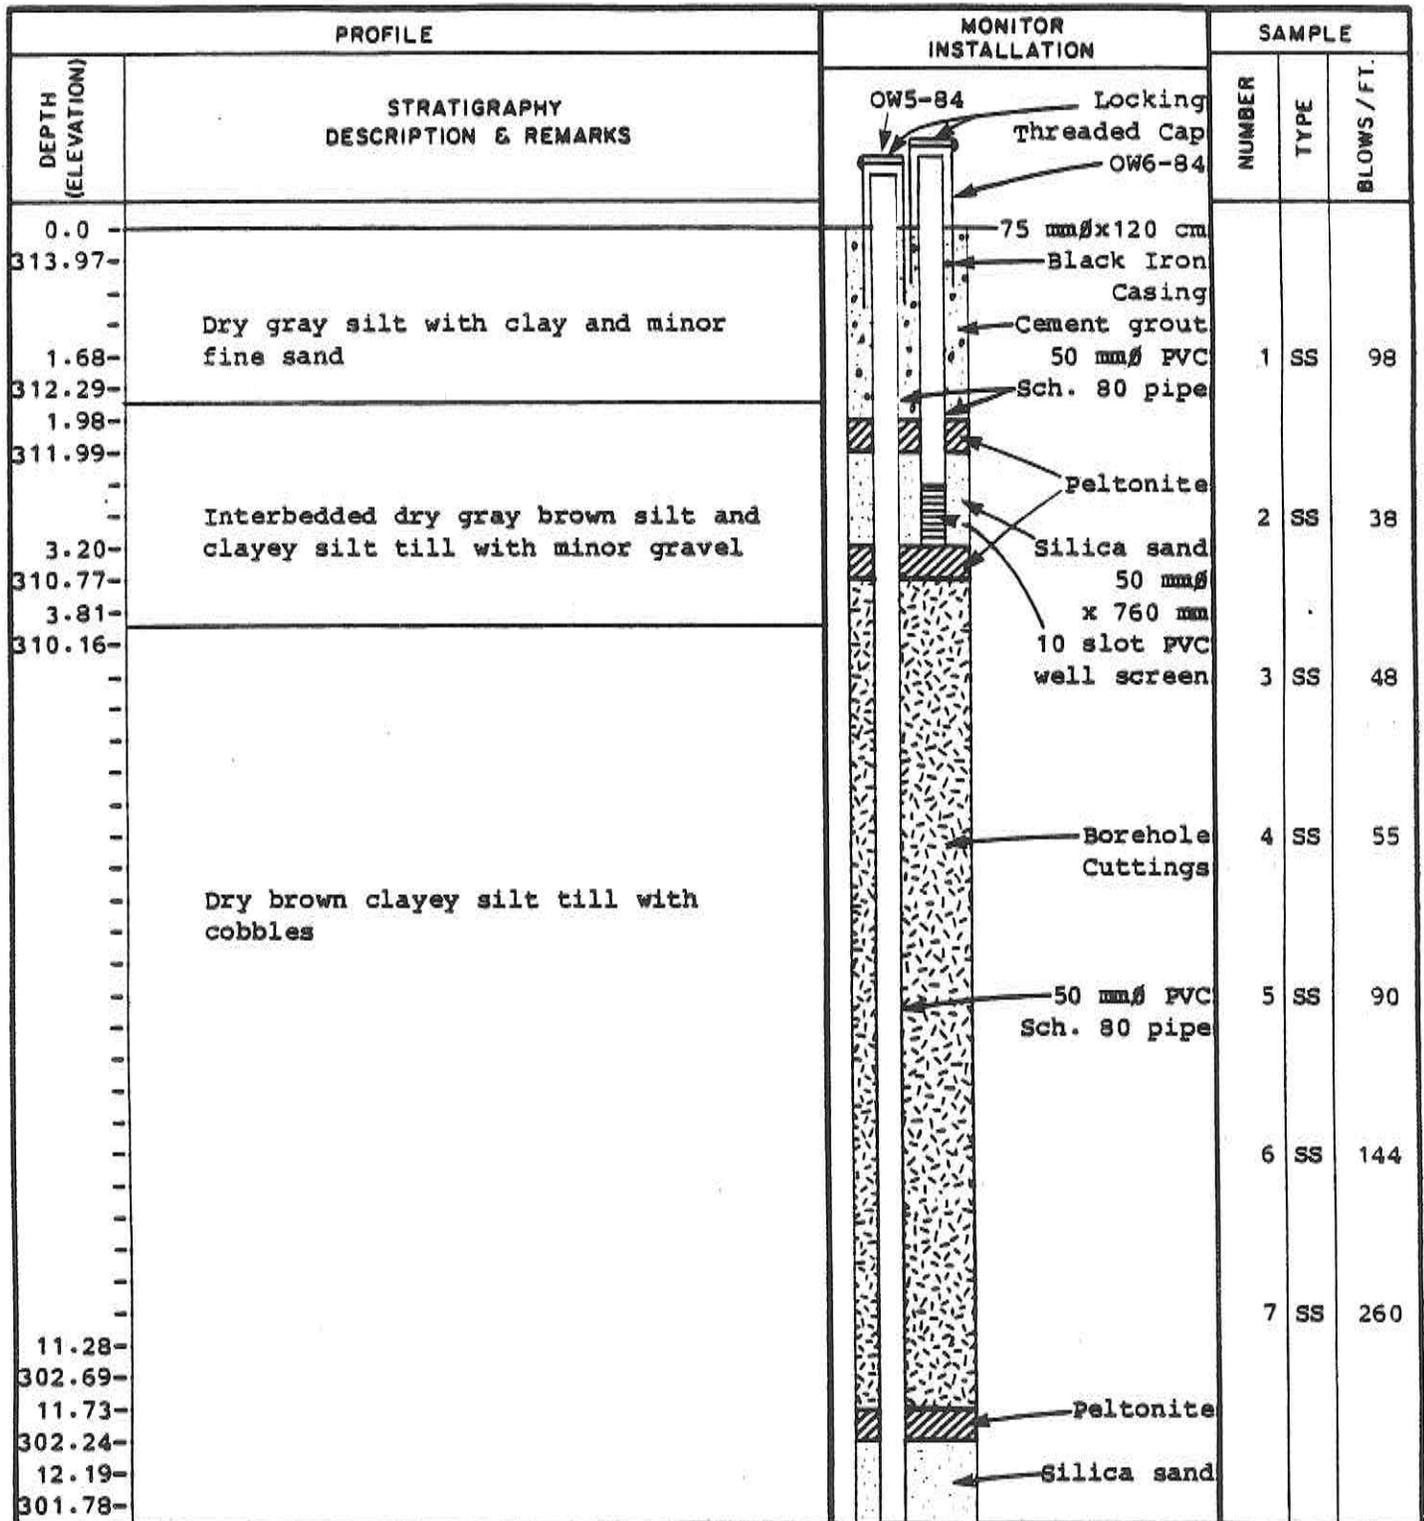
HOLE N° : OW5-84, OW6-84 - page 1 o
 DATE COMPLETED : SEPTEMBER 25, 1984
 GEOLOGIST/ENGINEER : PSB
 GROUND ELEVATION* : 313.97 m AMSL
 TOP OF PIPE ELEVATION* : 314.423, 314.794

Location	Soil	Thickness	Groundwater
OW3-84/ OW7-91	Fine to med sand	0.76	Dry
		1.3	moist
OW5-84	Med to coarse sand with gravel	1.98	Saturated
BH12-91	Fine Sand	0.76	dry

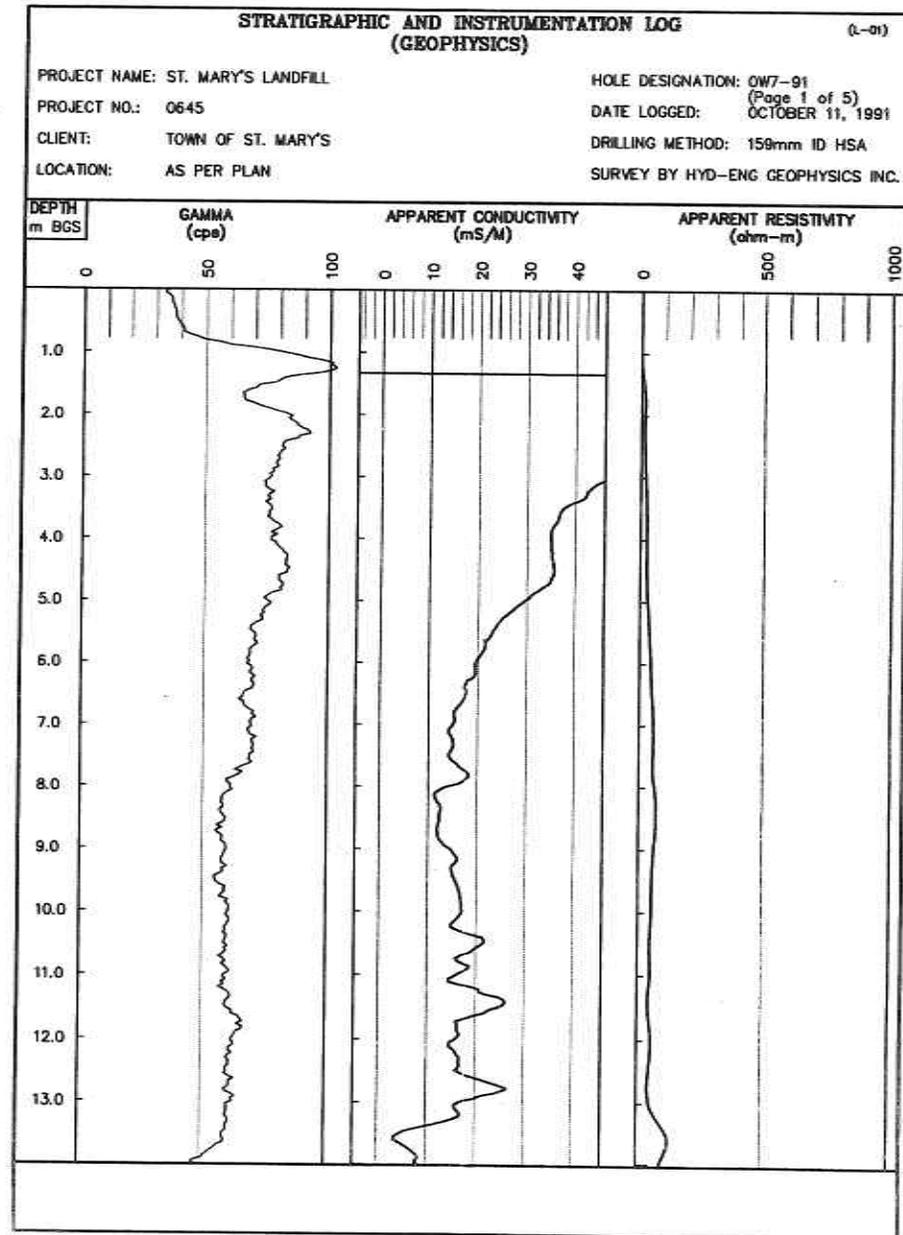
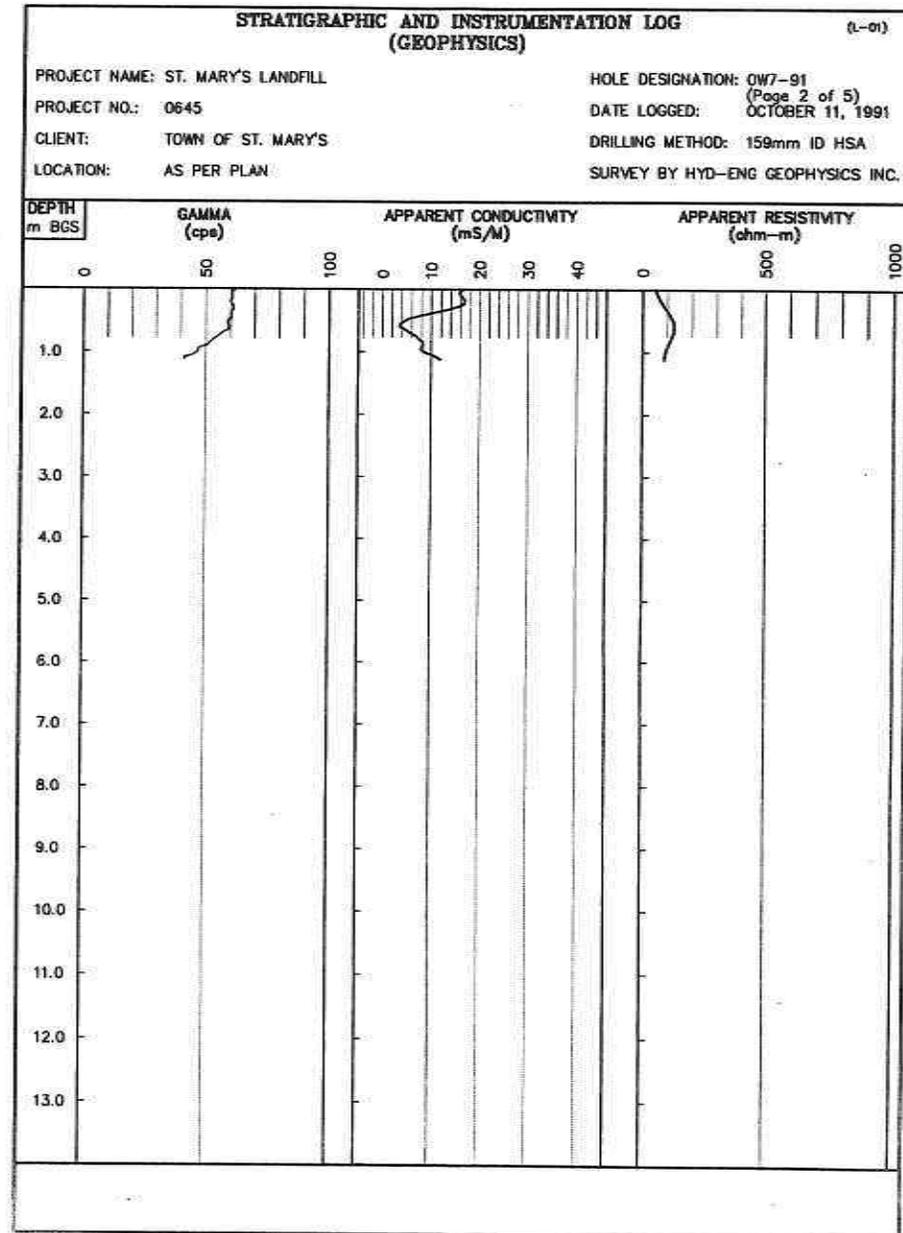
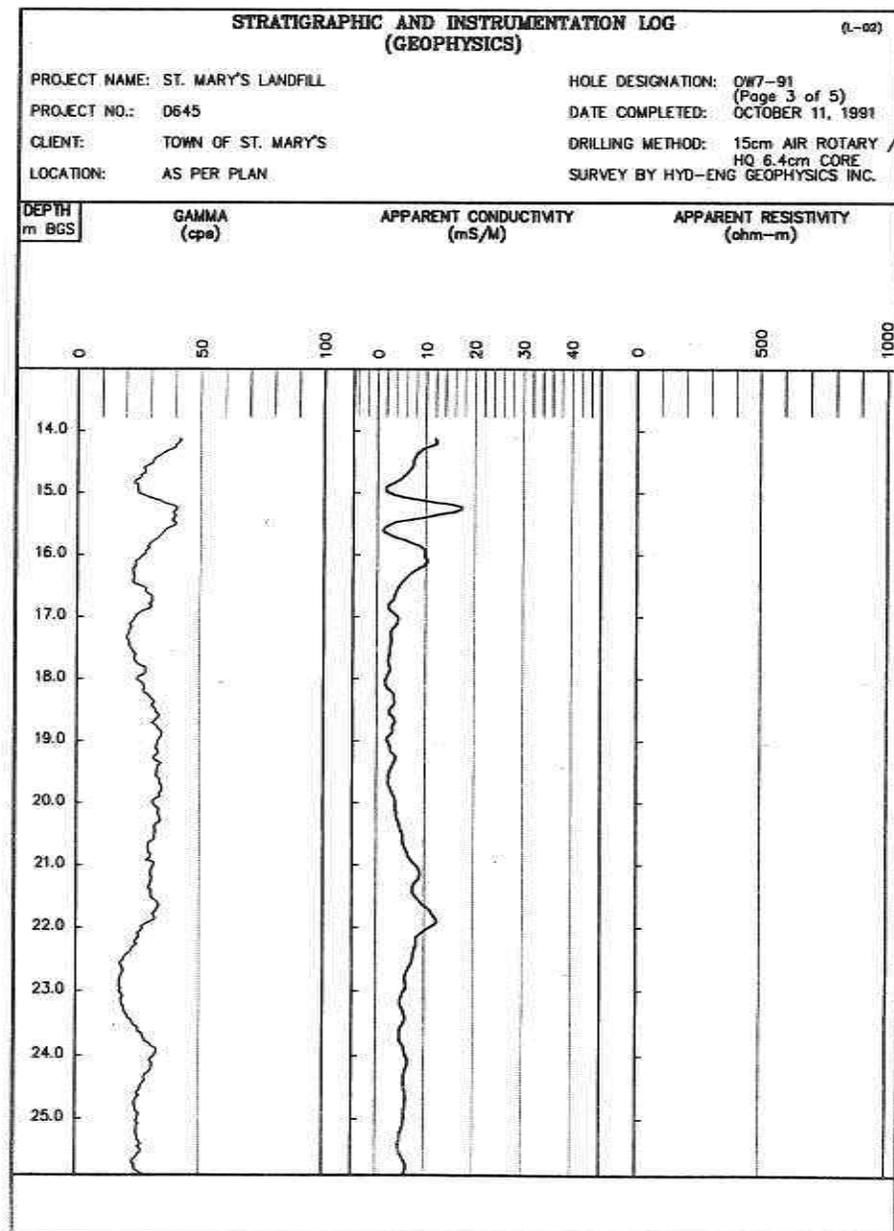
An unsaturated interval of bedrock of approximately 12 to 14 m in thickness was noted at each of the bedrock drilling locations. At OW7-91, OW8A-91 and OW9A-91, the bedrock core was taken just below the first indication of the bedrock water table and was found to be moderately fractured (RQD 30 to 45 percent), relatively competent (core recovery 100 percent) and contained numerous stylolites (pressure solution structures).

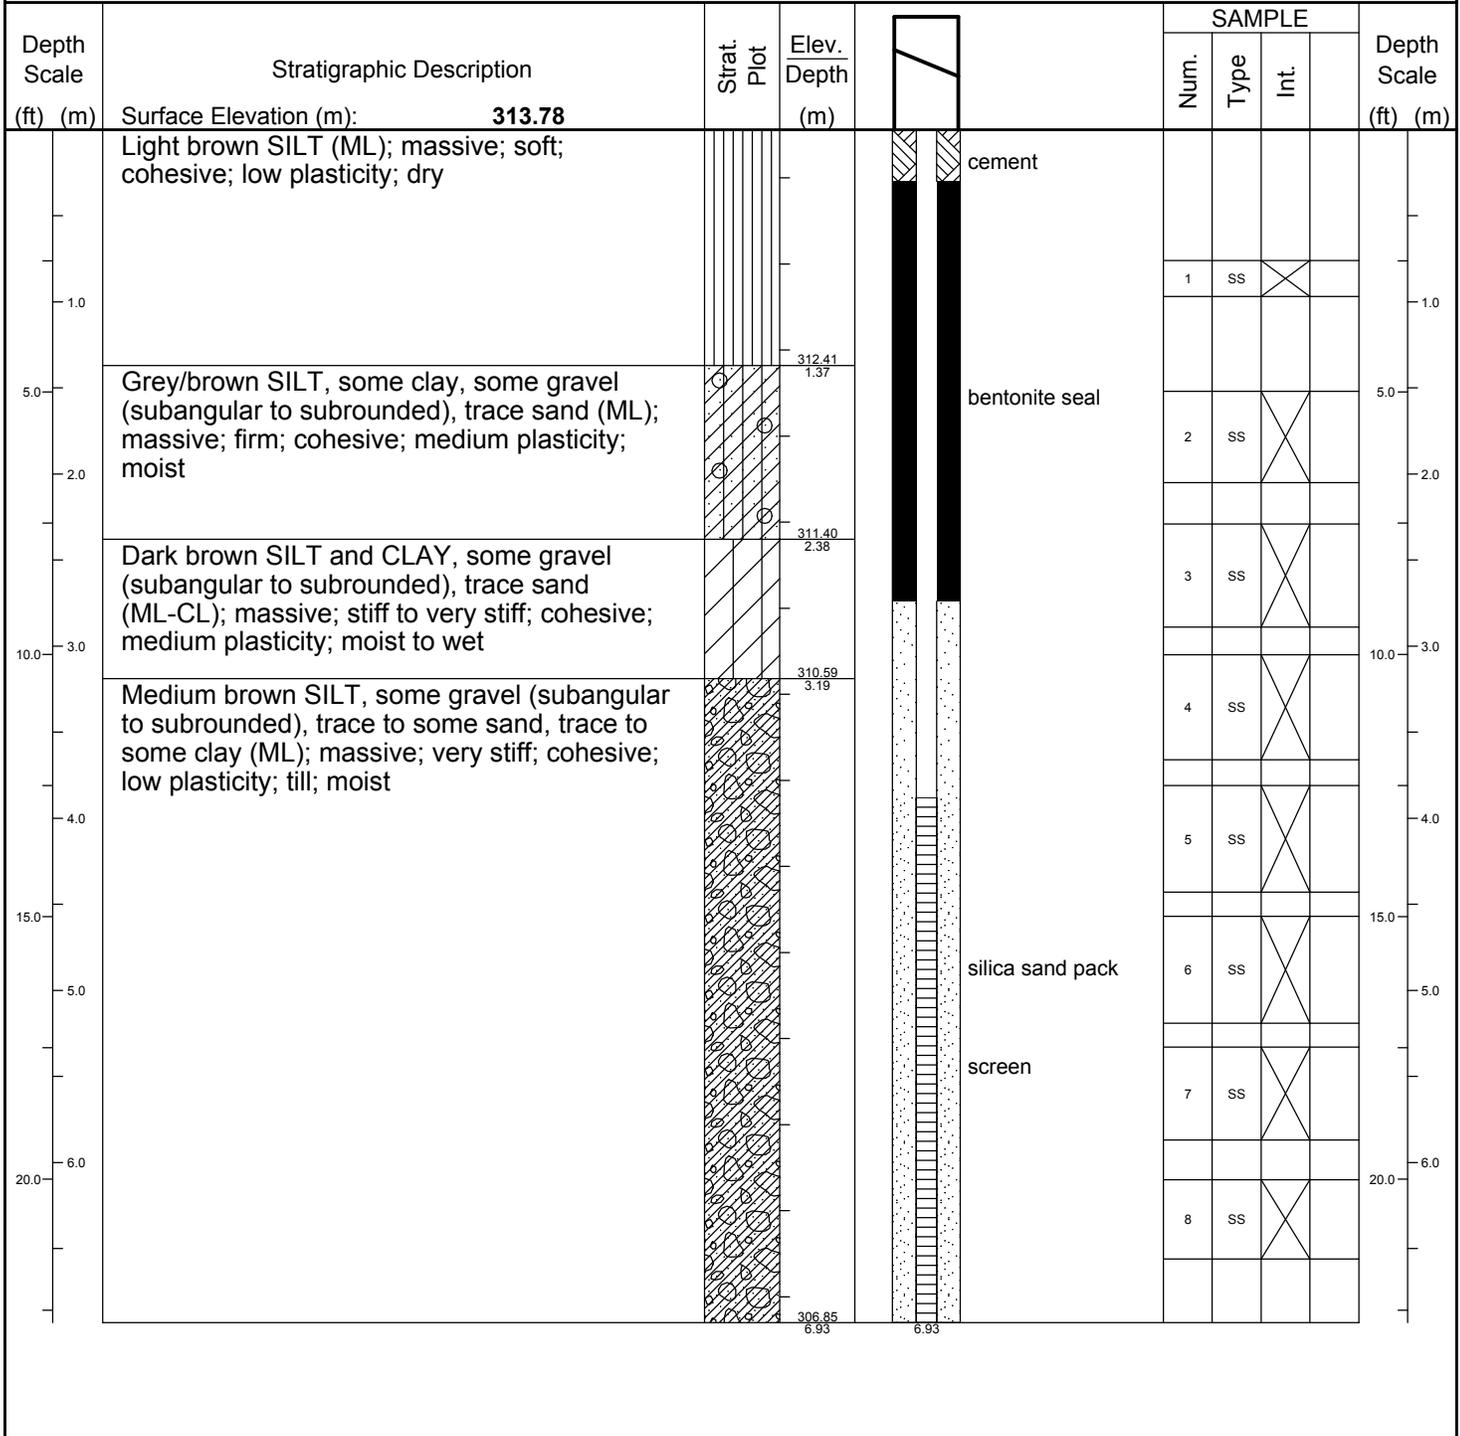
BHLOG GUELPH P:\GINT\PROJECTS\300 JOBS\300032339 ST. MARYS LANDFILL\032339 ST. MARYS 2016NOV29 OW36.GPJ TEMPLATE.GDT 11/21/17

In December 2015, a decision was made to defer the drilling program until later in the approval stage. A call was made to the MOECC to discuss this alteration to the Work Plan. Burnside suggested that delaying installation until the configuration of Site facilities had been determined would result in a better monitoring network. However, one new well was added in November 2016 following additional discussions with the MOECC. This well, OW36, was installed downgradient of the Phase II/III fill area.
