Sewage System Maintenance Inspection Road 120, St. Marys Ontario

Introduction

GRIT Engineering Inc. (GRIT) was retained by C&C Stonetown Management to conduct a Phase I Sewage System Maintenance Inspection at 60 Road 120 in St. Marys, Ontario (the Site) as seen in Figure 1 in Appendix A. It is noted this inspection was completed with guidelines provide by the Ministry of Municipal Affairs and Housing. Phase I inspections involve a review of available material, including information collected in the identification phase and reports from previous inspections.

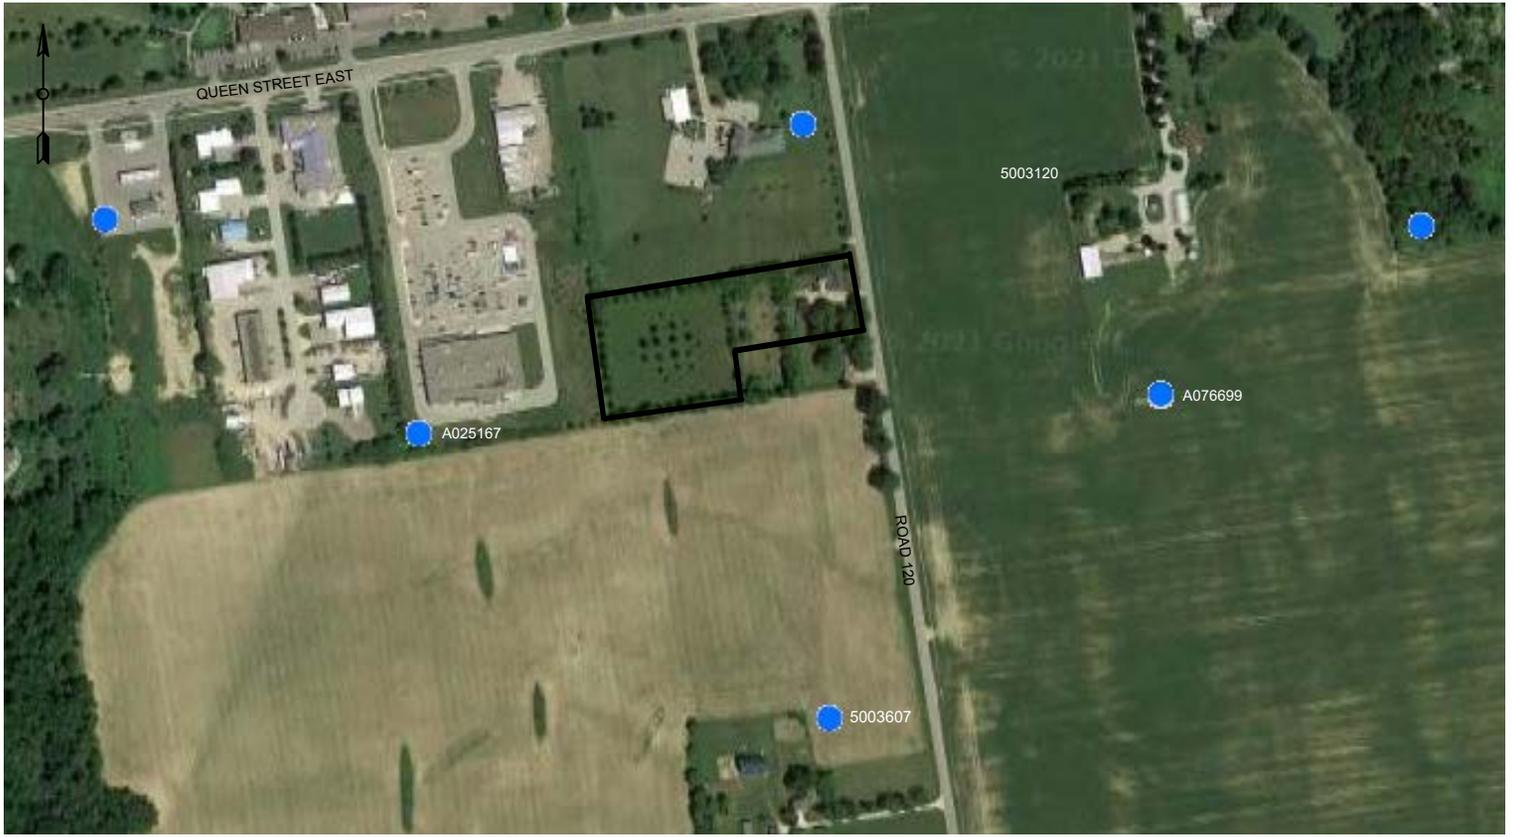
SEWAGE SYSTEM MAINTENANCE INSPECTION
WELL LOCATIONS

WELL LOCATIONS

Based on the Well Records Map provided by the Ministry of the Environment (MOE), groundwater elevation is expected to be approximately 38-45 metres below ground surface (mbgs). Four wells were identified to the north, east, south and west of the Site. Well locations can be seen on Figure 4 in Appendix A. Well records can be found in Appendix B, and pertinent details are outlined in the table below.
